## **B: SITE PHOTOGRAPHS**

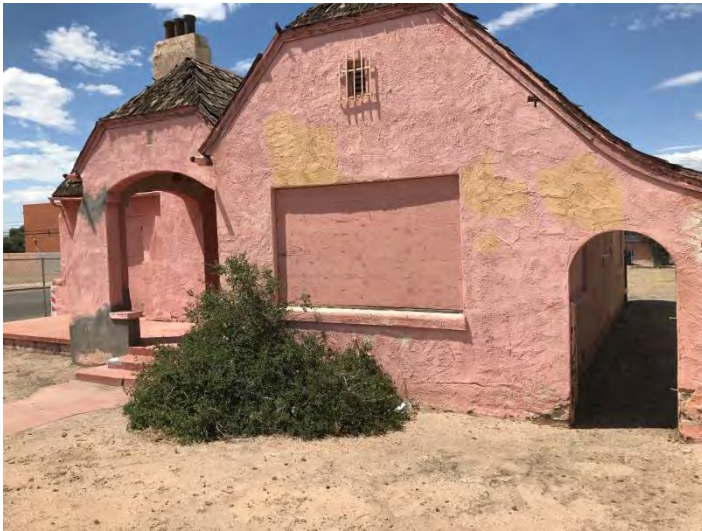
**Photo No. B-1**

**Description:** Residential structure located on the southern portion of 1601 E. Broadway Blvd. The stucco for the structure is suspect ACMB and the paint is suspect for lead-based paint.

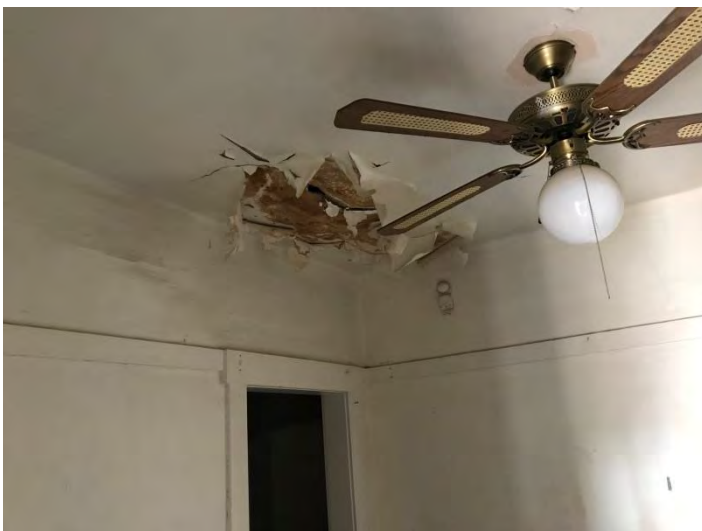
**Photo No. B-2**

**Description:** Interior of the southern structure showing ceiling damage.

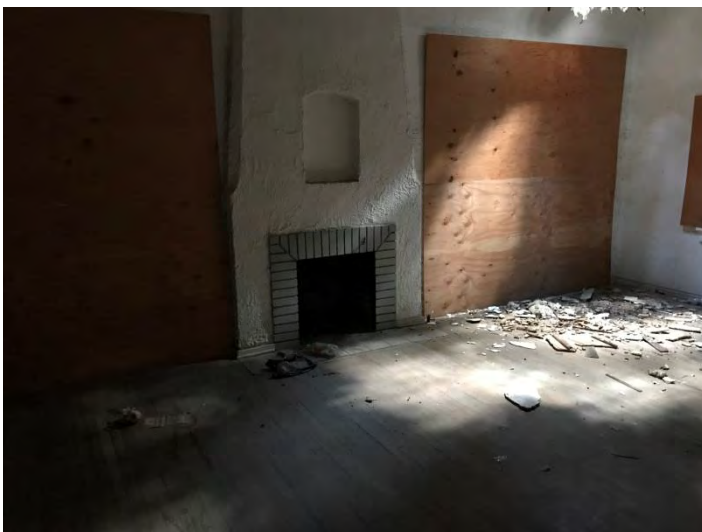
**Photo No. B-3**

**Description:** Interior of the southern structure showing living room. The textured drywall is suspect for ACBM.

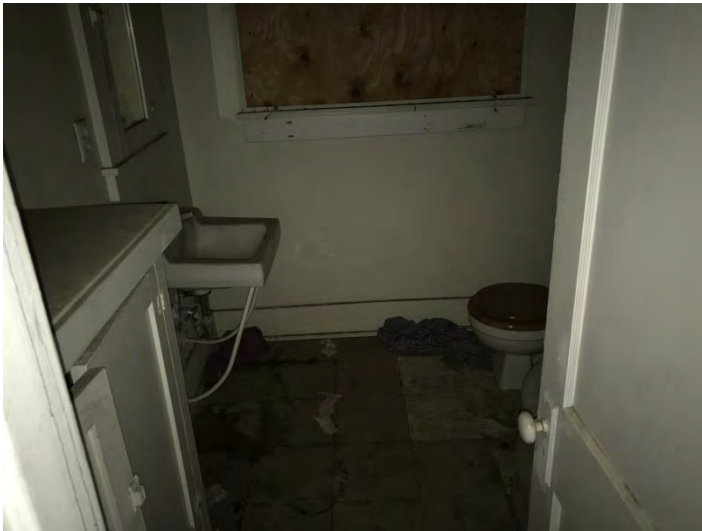
**Photo No. B-4**

**Description:** Interior of the southern structure showing restroom. The floor tile is suspect ACBM.

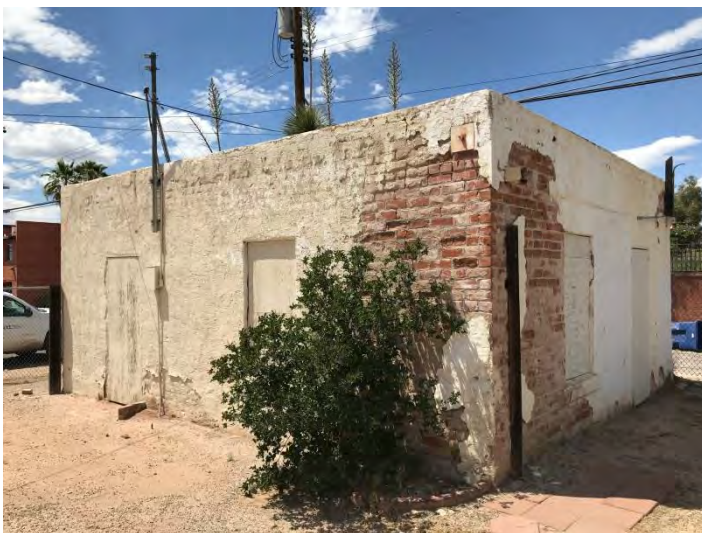
**Photo No. B-5**

**Description:** Northern portion of the subject property at 1601 E. Broadway Blvd. showing additional structure. The paint on the structure is suspect for lead-based paint and the brick and mortar are suspect ACMB.

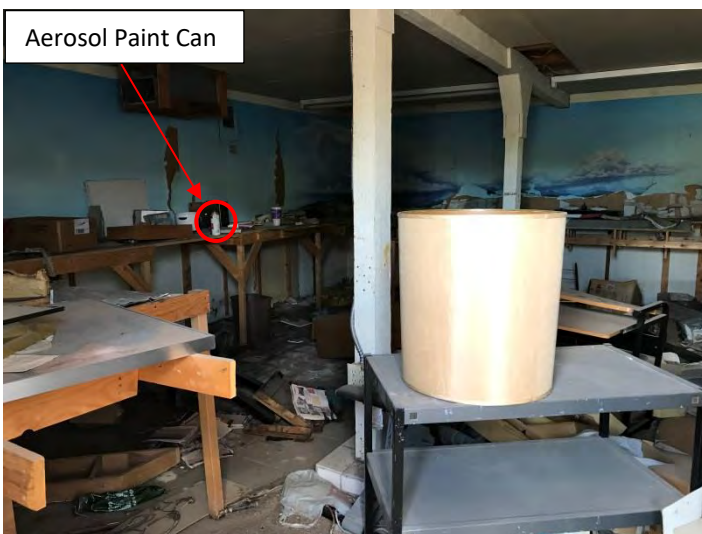
**Photo No. B-6**

Aerosol Paint Can

**Description:** Interior of the northern structure showing miscellaneous items and one aerosol paint can.

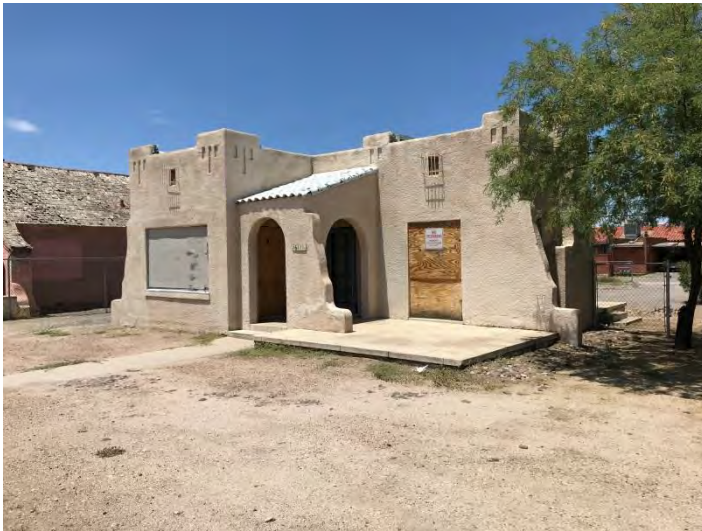
**Photo No. B-7**

**Description:** Residential structure located at 1611 E. Broadway Blvd. The stucco for the structure is suspect ACMB and the paint is suspect for lead-based paint.

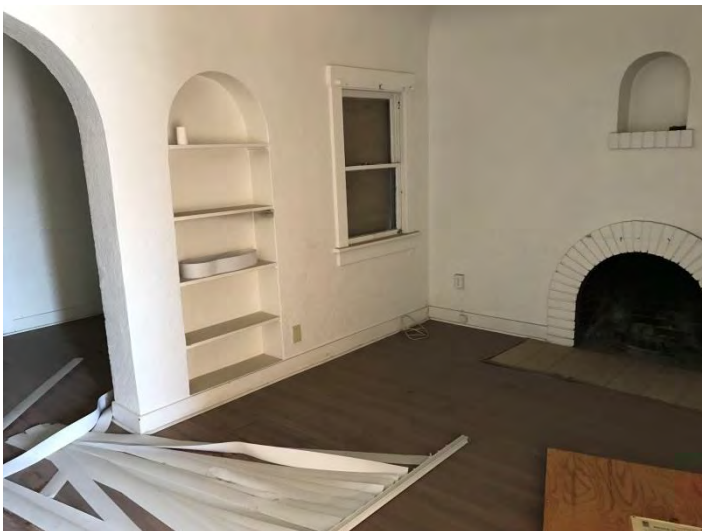
**Photo No. B-8**

**Description:** Interior of the structure showing living room. The textured drywall is suspect for ACBM.

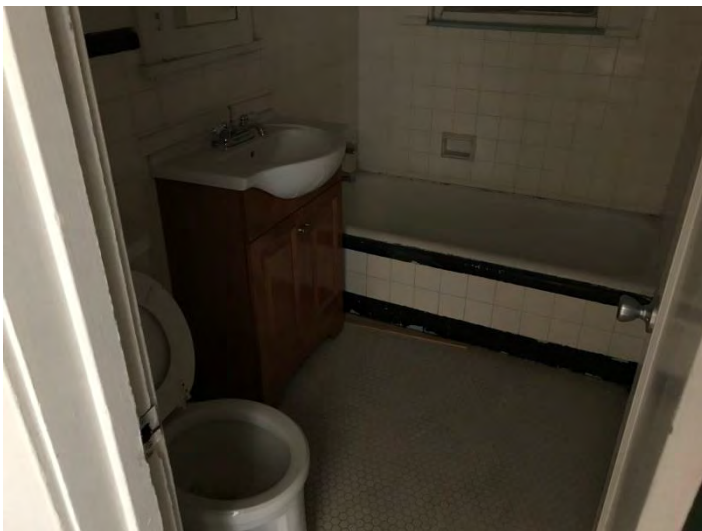
**Photo No. B-9**

**Description:** Interior of the structure showing restroom. The floor and wall tile are suspect ACBM.

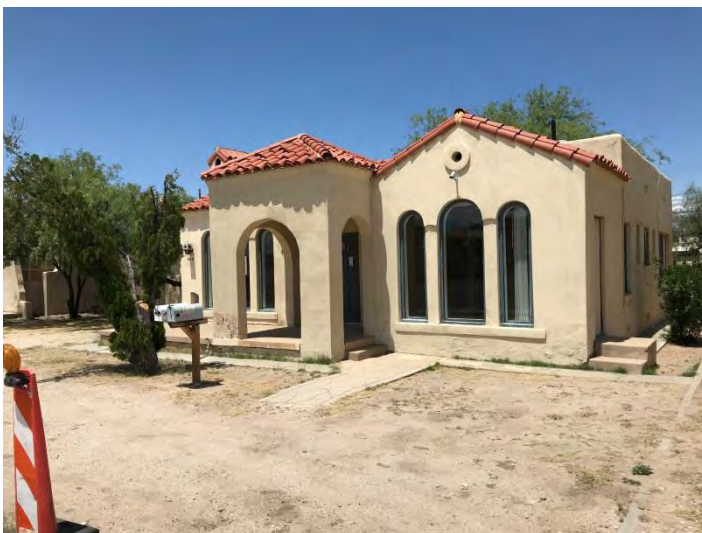
**Photo No. B-11**

**Description:** Residential structure located on the southern portion of 1615 E. Broadway Blvd. The stucco for the structure is suspect ACMB.

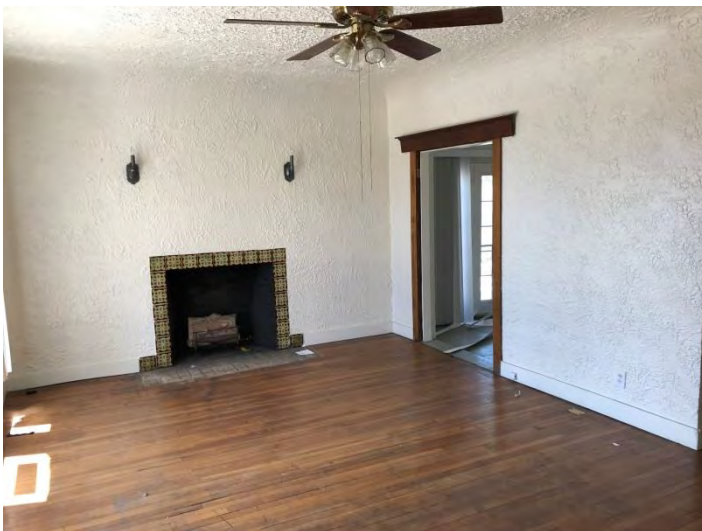
**Photo No. B-12**

**Description:** Interior of the structure showing living room. The textured drywall is suspect for ACBM.

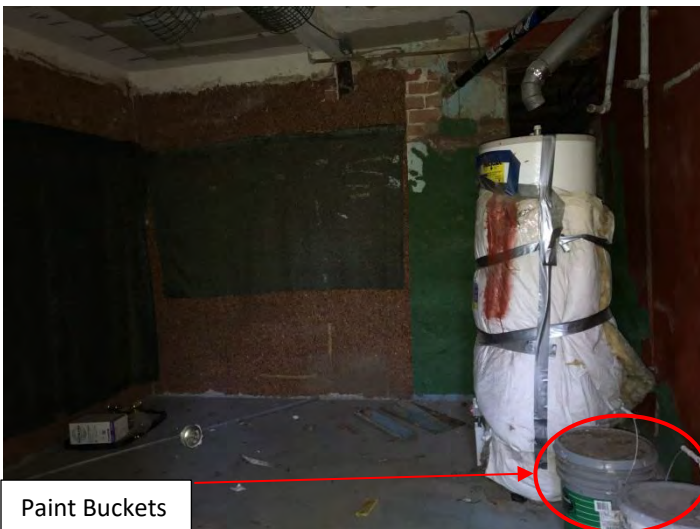
**Photo No. B-15**

Paint Buckets

**Description:** Interior of basement showing water heater and two 5-gallon buckets of paint. The concrete foundation is suspect ACBM.

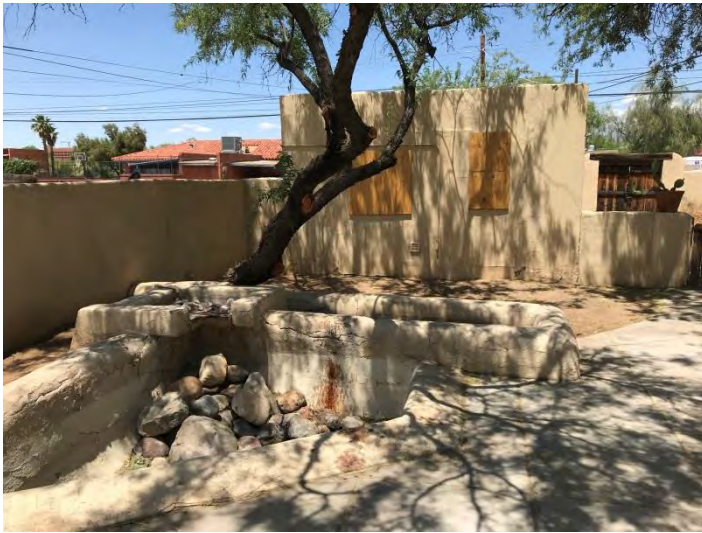
**Photo No. B-16**

**Description:** Northern portion of the subject property at 1615 E. Broadway Blvd. showing additional structure and concrete fountain. The concrete fountain is suspect ACBM.

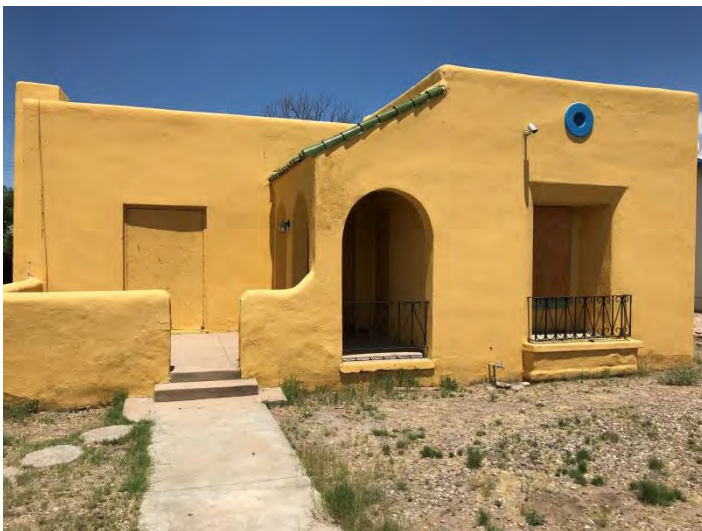
**Photo No. B-18**

**Description:** Residential structure located on the southern portion of 1625 E. Broadway Blvd. The stucco for the structure is suspect ACMB and the paint is suspect for lead-based paint.

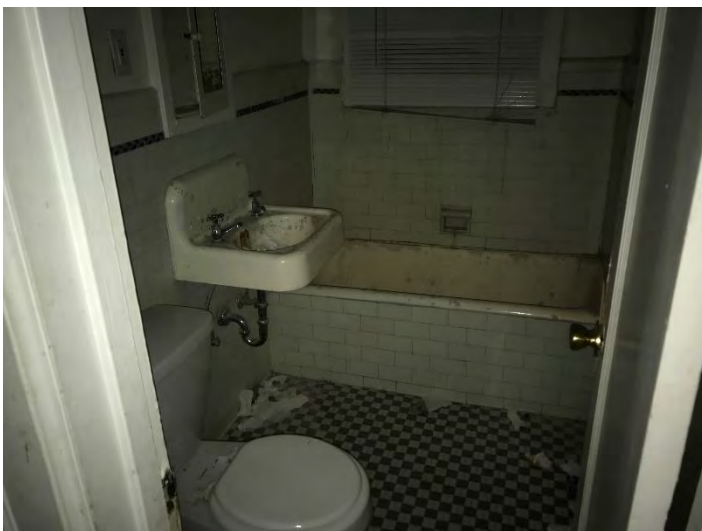
**Photo No. B-20**

**Description:** Interior of the southern structure showing restroom. The tile is suspect ACBM.

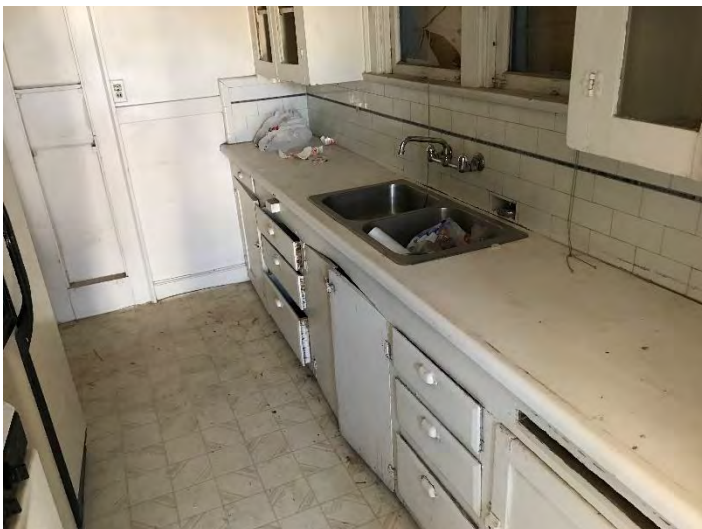
**Photo No. B-21**

**Description:** Interior of the southern structure showing kitchen. The tile is suspect ACBM.

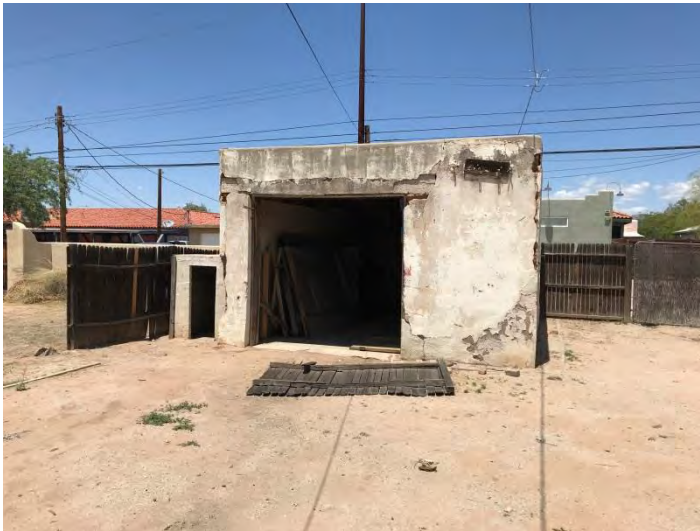
**Photo No. B-22**

**Description:** Northern portion of the subject property at 1625 E. Broadway Blvd. showing additional structure. The paint on the structure is suspect for lead-based paint and the stucco is suspect ACMB.

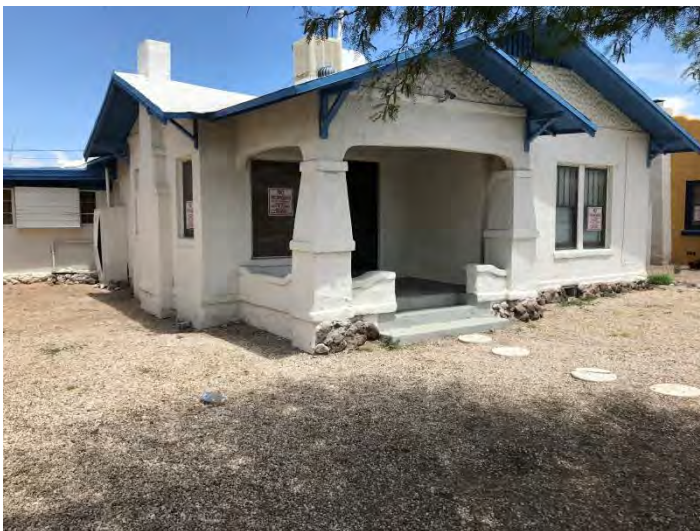
**Photo No. B-24**

**Description:** Residential structure located on the southern portion of 1629 E. Broadway Blvd. The stucco for the structure is suspect ACMB and the paint is suspect for lead-based paint.

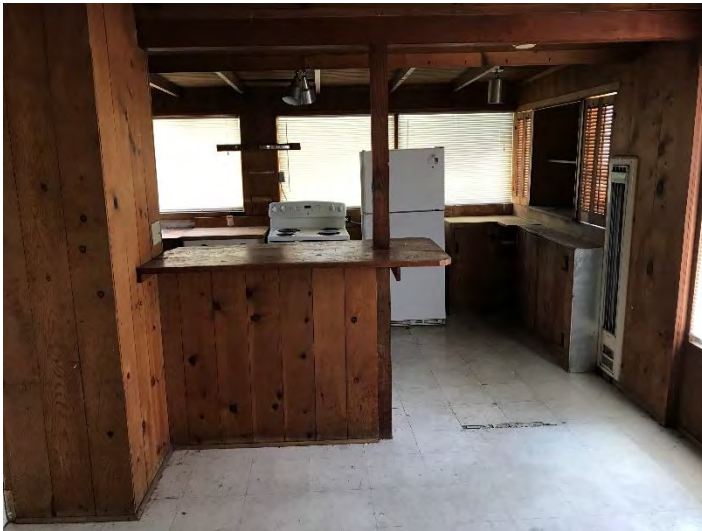
**Photo No. B-25**

**Description:** Interior of the southern structure showing kitchen. The tile is suspect ACBM.

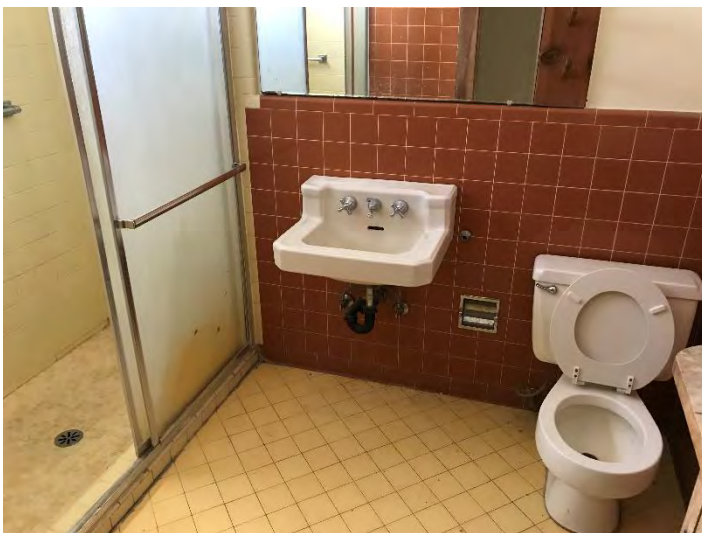
**Photo No. B-26**

**Description:** Interior of the southern structure showing restroom. The tile is suspect ACBM.

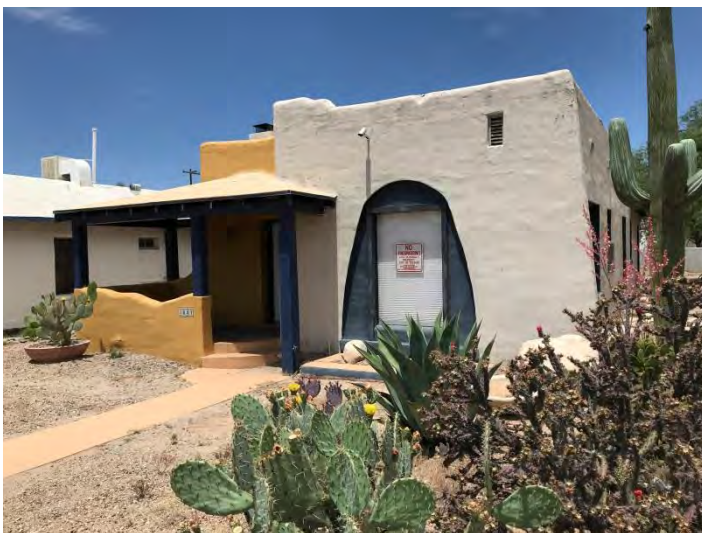
**Photo No. B-29**

**Description:** Residential structure located on the southern portion of 1641 E. Broadway Blvd. The stucco for the structure is suspect ACMB and the paint is suspect for lead-based paint.

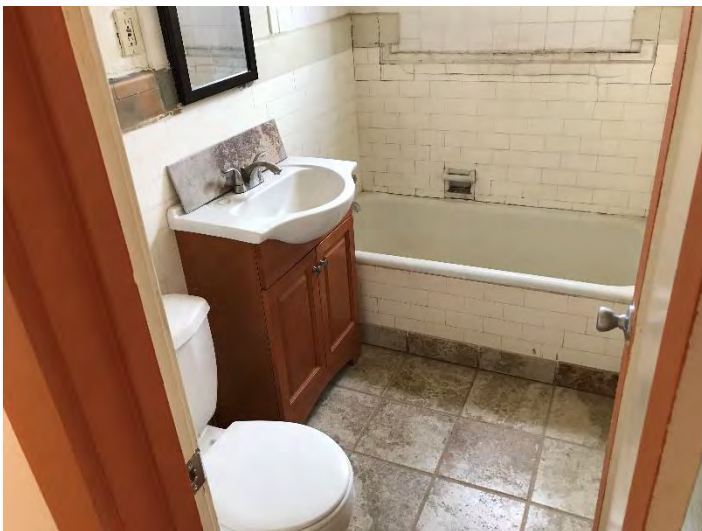
**Photo No. B-30**

**Description:** Interior of the structure showing restroom. The wall tile is suspect ACBM.

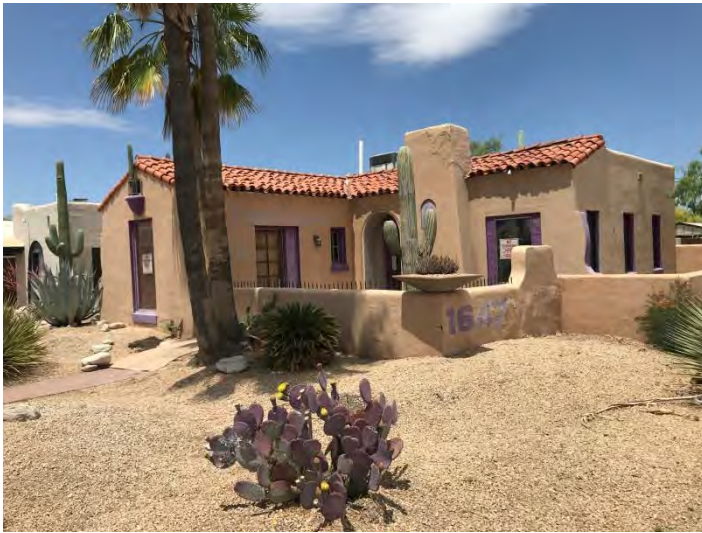
**Photo No. B-34**

**Description:** Residential structure located on the southern portion of 1647 E. Broadway Blvd. The stucco for the structure is suspect ACMB and the paint is suspect for lead-based paint.

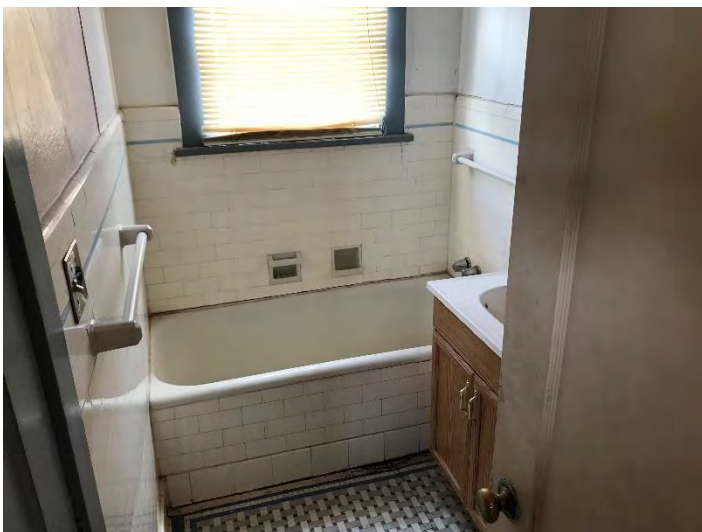
**Photo No. B-36**

**Description:** Interior of the structure showing restroom. The wall tile is suspect ACBM.

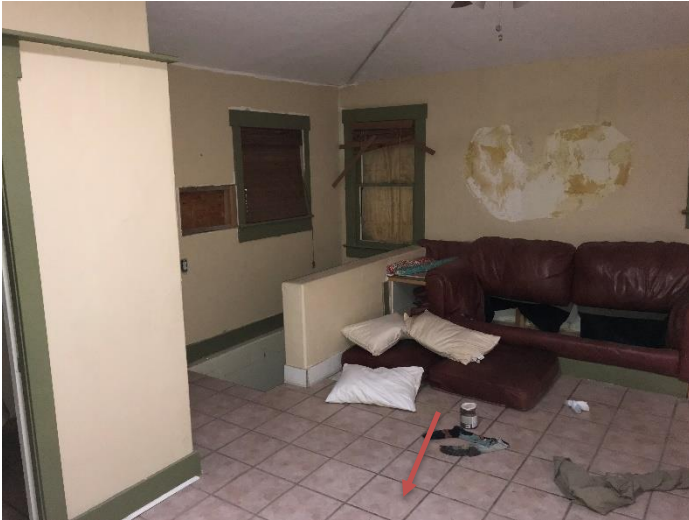
**Photo No. B-1**

**Description:** 12" by 12" ceramic floor tile with underlying mastic

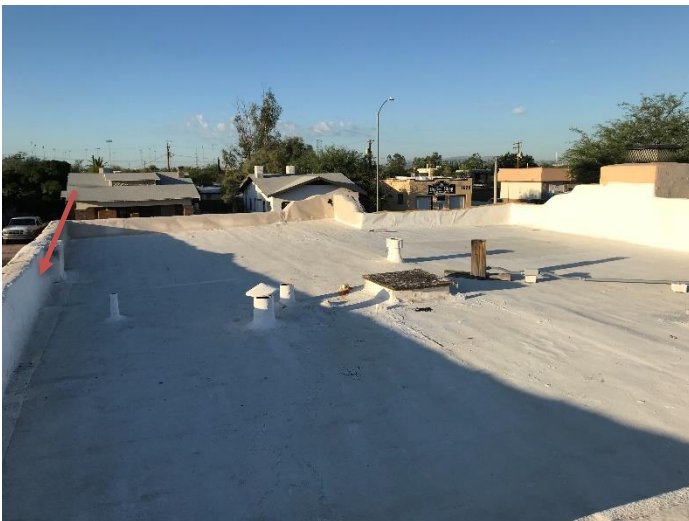
**Photo No. B-2**

**Description:** Asphalt roofing material with asbestos-containing roofing tar (caulking)

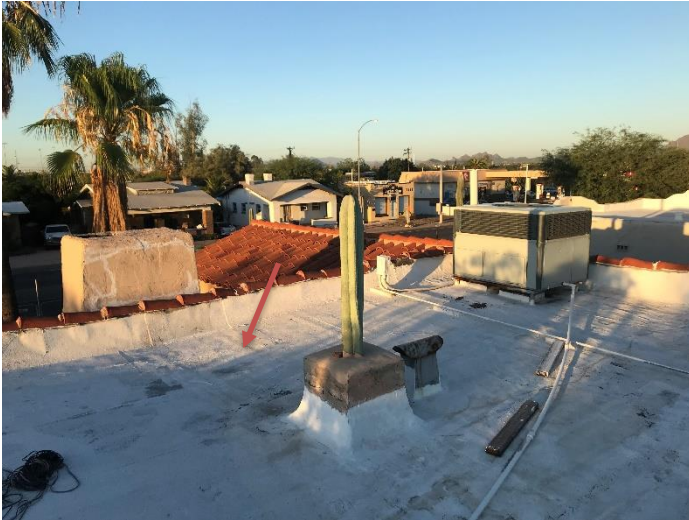
**Photo No. B-1**

**Description:** Asbestos-containing roofing materials

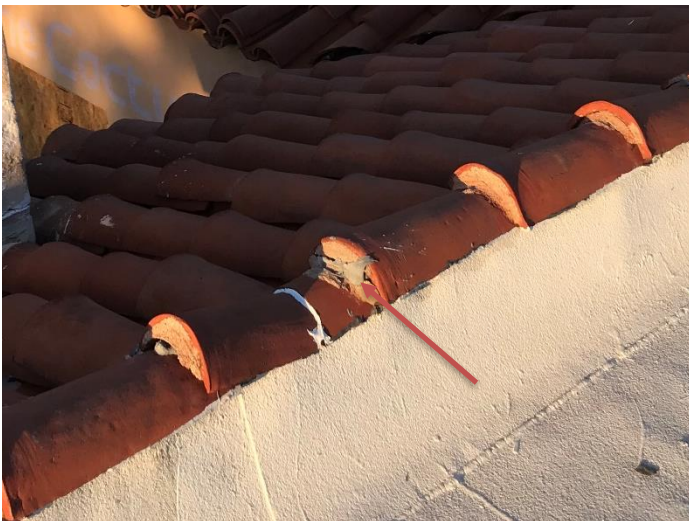
**Photo No. B-2**

**Description:** Asbestos-containing roofing tar associated with the clay roofing tiles

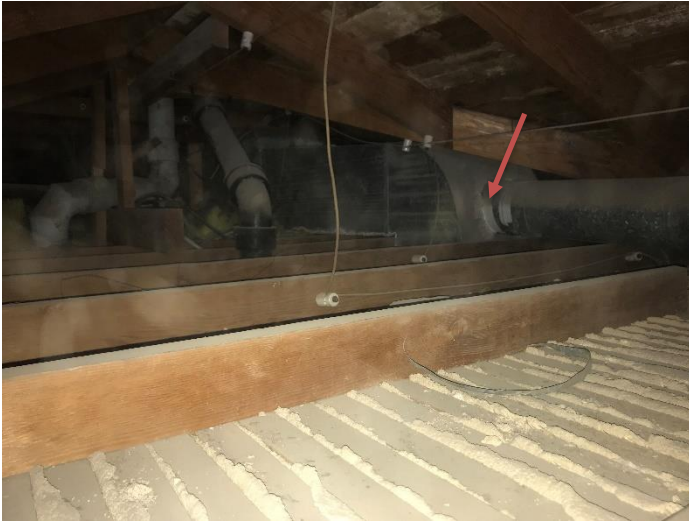
**Photo No. B-4**

**Description:** Asbestos-containing duct tape.

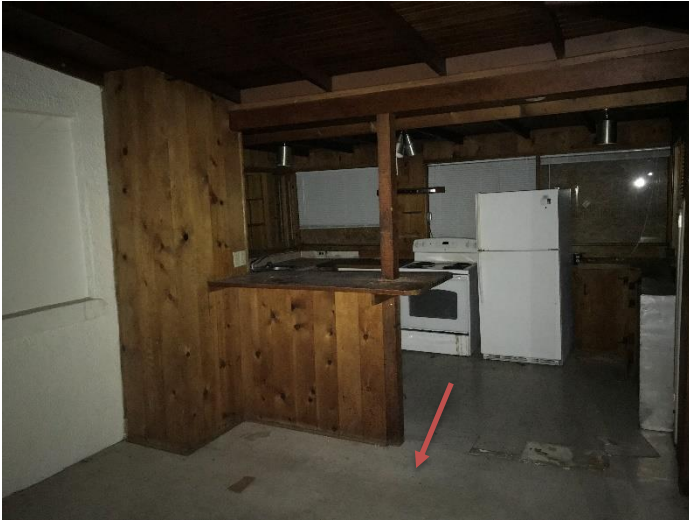
**Photo No. B-1**

**Description:** Beige floor tile with asbestos under layer in the kitchen and dining areas

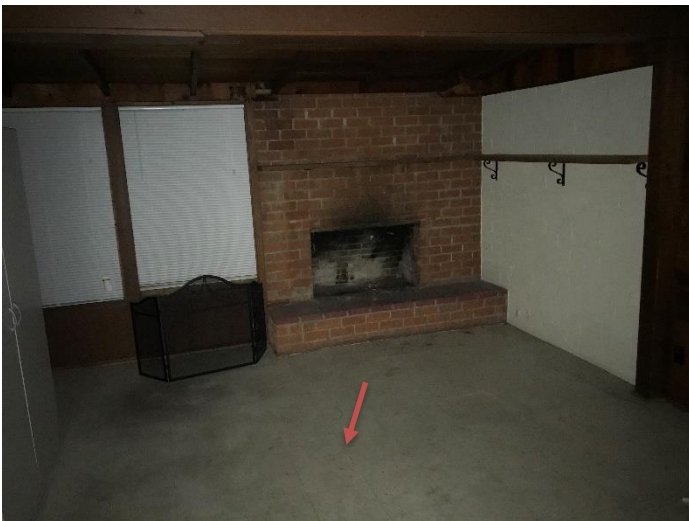
**Photo No. B-2**

**Description:** Beige floor tile with asbestos under layer in the den

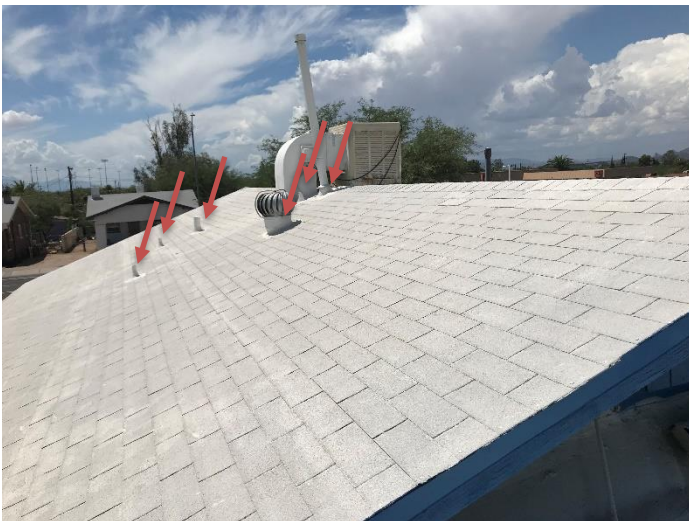
**Photo No. B-5**

**Description:** Asbestos-containing roofing tar (all penetrations)

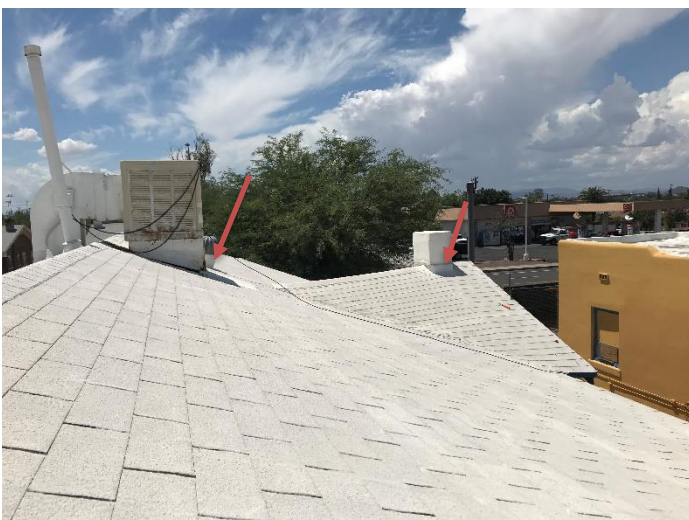
**Photo No. B-6**

**Description:** Asbestos-containing roofing tar (all penetrations)
