GRENIER ENGINEERING, INC.

Re: Structural Feasibility Report: The Indian Trading Post – 72 E. Congress, Tucson, AZ
GEI Project 17021

Per your request, on behalf of Bourn Companies, LLC (Building Owner), and in accordance with our agreement dated February 20, 2017, we are providing you with this Feasibility Report for the above referenced building. The purpose of this report is to provide a structural assessment of the building in its current condition, based on visual observations and limited preliminary analysis, to determine the structural integrity of the building. We will also evaluate the extent of deficiencies that the building may have with respect to the International Existing Building Code (IEBC), and applicable portions of the 2012 International Building Code (IBC). This will be required since the building has been vacant (not occupied) for an extended period of time, and, the owner desires to convert the building to restaurant use (change of use from the original office use).

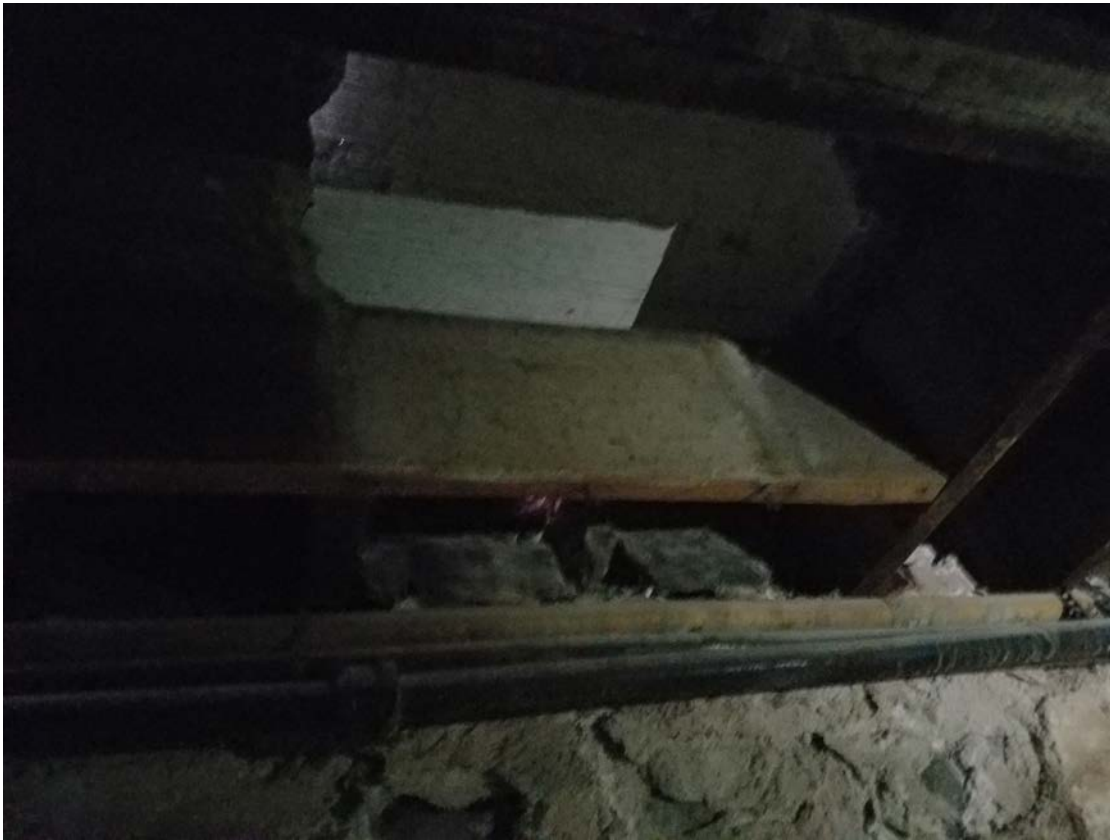
2. The basement perimeter walls are a stone rubble retaining wall on all sides. Certain sections of the basement wall appear to have been shotcrete covered on the interior face with a layer of concrete estimated at 1" to 2" thick based on a small section that has spalled off.

3. The width of the stone wall is assumed to be at least 16" to carry the four wythe brick wall above. The mortar used in the original construction of these walls is severely deteriorated and loose, assumedly due to years of moisture wicking thru the wall.

6. The stone rubble basement walls are extremely deteriorated, and in our opinion should be considered unsafe and will need to be strengthened.
7. The roof trusses are extremely deteriorated and in many cases broken. We did not analyze the trusses since it is our opinion that they must be replaced.

Figure 1 - Stone Rubble Basement Wall and Floor Joists

1. The basement stone rubble walls must be strengthened. We have attached detail CS1 that show a possible solution using a 12" thick shotcrete concrete wall and footing. The base of these walls would be braced by a new reinforced concrete slab cast on top of the existing thin slab. The top of these walls would be braced by the ground floor level framing. An option to the shotcrete wall would be a 12" thick solid grouted CMU wall with #6 bars each face at 8" on center.

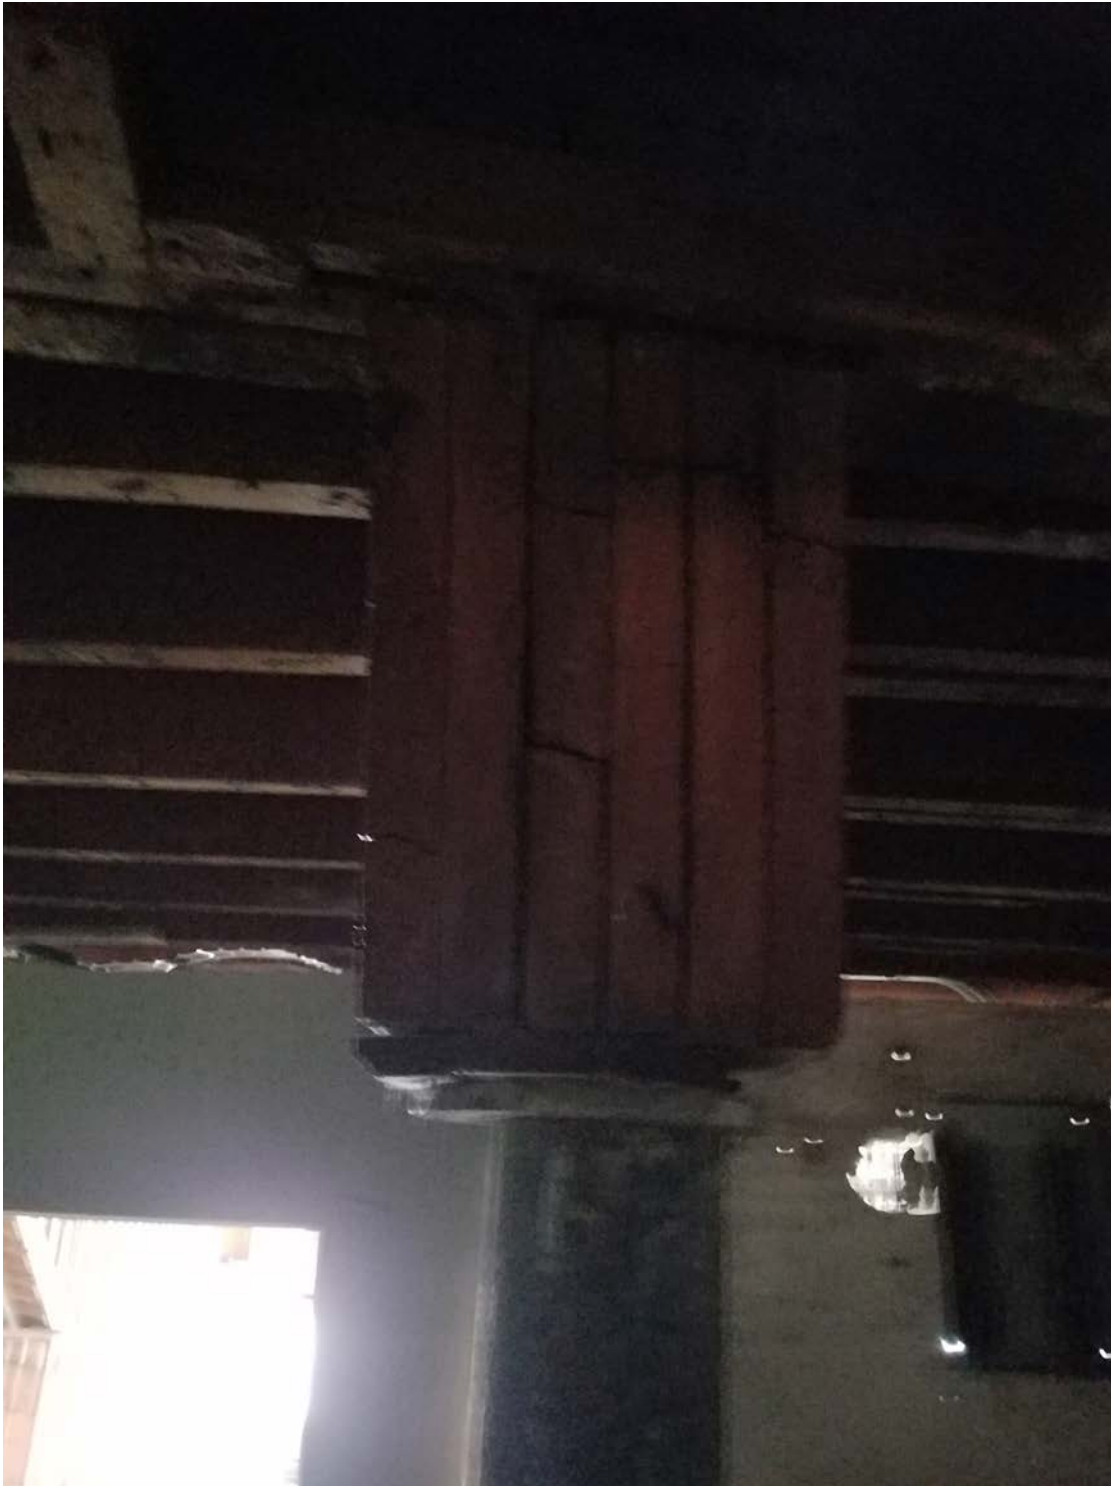
4. The floor framing is similar to that of the ground floor, except the joist spacing appears to be 16" on center and not 18". These floor joists are pocketed into the brick walls on the east and west sides, and also span east to west onto a wood girder at approximately the middle of the building. The girder at the second floor is built with six 2 x 14-1/2 wood joists, connected together forming a 12" wide x 14-1/2" deep beam. The girders at this level are supported on wood columns.

3. The original use of the building is assumed to have been either office space (live load of 50 psf and 100 or 80 psf at corridors), and possibly retail space on the ground floor (live load of 100 psf). The proposed space is an assembly use with a live load of 100 psf (no reductions based on tributary area is allowed). We ran some preliminary calculations on the framing using a 100 psf live load and discovered the following: a) the floor joists appear to be adequate if we assume they are Douglas – Fir select structural grade, and if they are not distressed; b) the girders at the middle of the building are not adequate and will need to be strengthened or replaced.

Figure 2 - Built Up Wood Girder and Post Below Second Floor Level

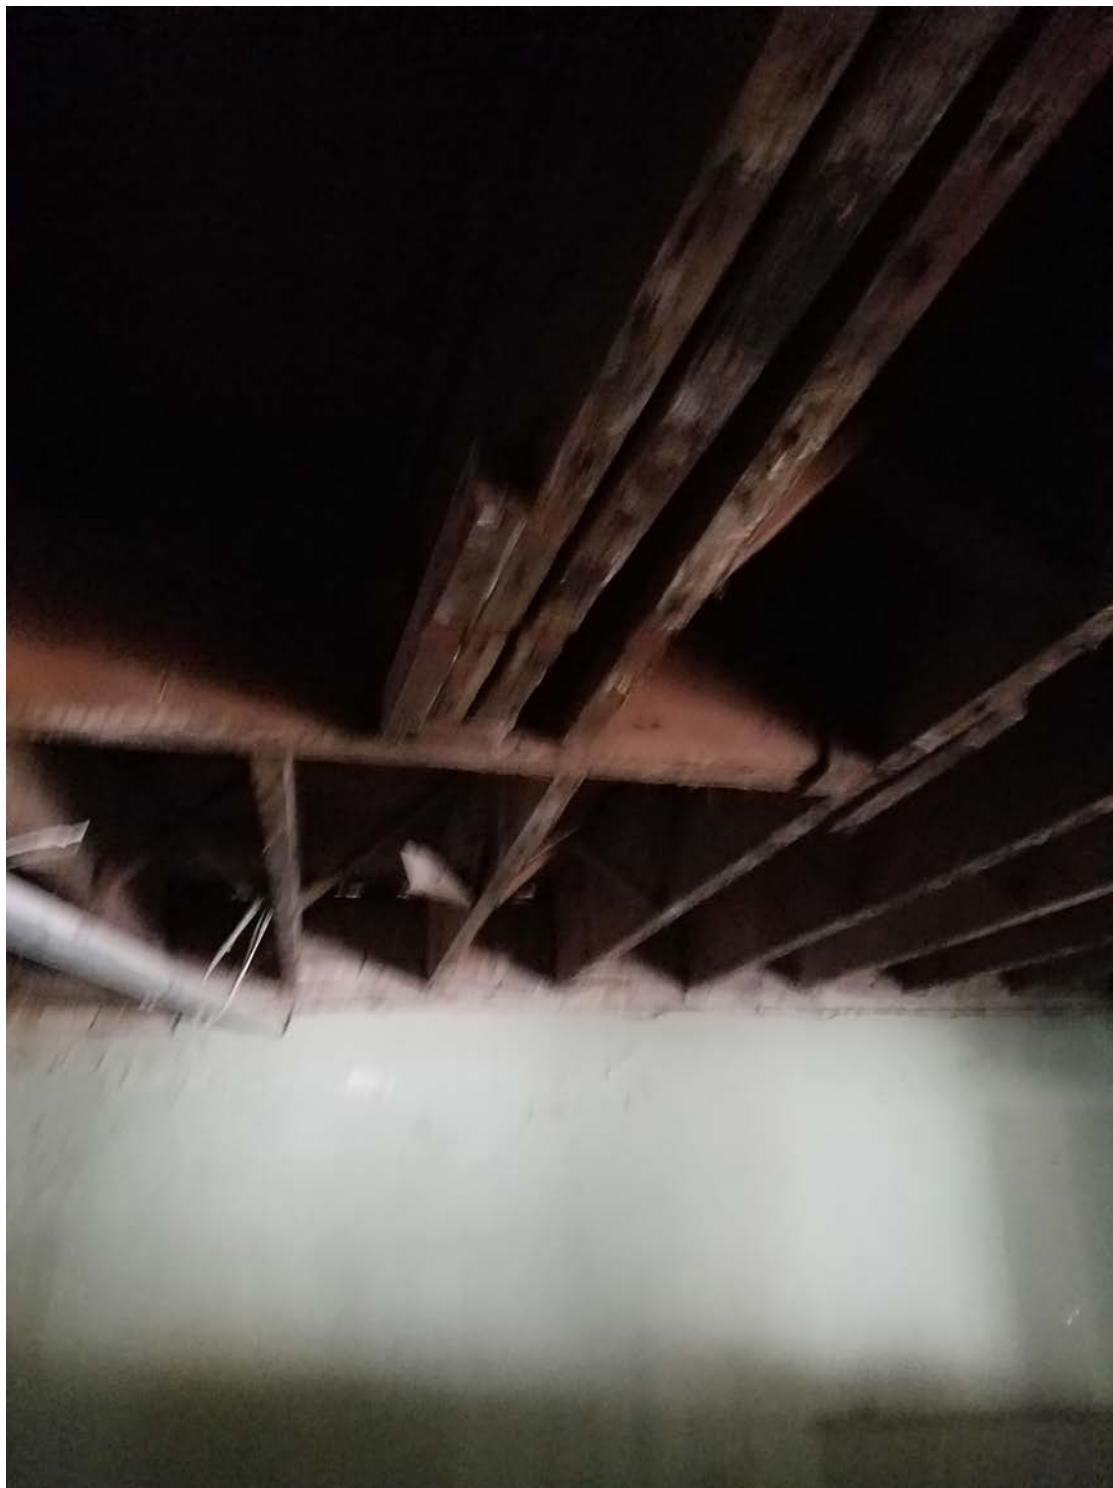
5. The floor framing consists of 2 layers of straight wood decking (in extremely poor condition) spanning to 2" wide x 14-1/2" deep wood joists spaced at +/- 18" on center. These joists are pocketed into the rubble basement walls on the east and west sides, and span east to west onto a wood girder at approximately the middle of the building. The girder is built with seven of the 2 x 14-1/2 wood joists, connected together forming a 14" wide x 14-1/2" deep beam. The girders have four spans in the north south direction, and bear on three large (+/- 36" square) brick piers / columns. We were not able to observe any foundations. It was observed that there is fire damage with significant char to several joists and to the wood girder.

Figure 3 - Floor Framing

2. The ground floor framing is recommended to be strengthened as shown on the attached concept ground floor level framing plan. The existing 2 x 14-1/2 joists can remain in place, with additional LVL joists added wherever needed. We are recommending adding new steel girders at the middle of the building that would bear on new steel columns and new concrete spread footings. This allows the loads to be carried on new footings (the existing brick piers are of unknown quality and capacity), and the new columns would extend up to the second floor and the roof to carry those loads.

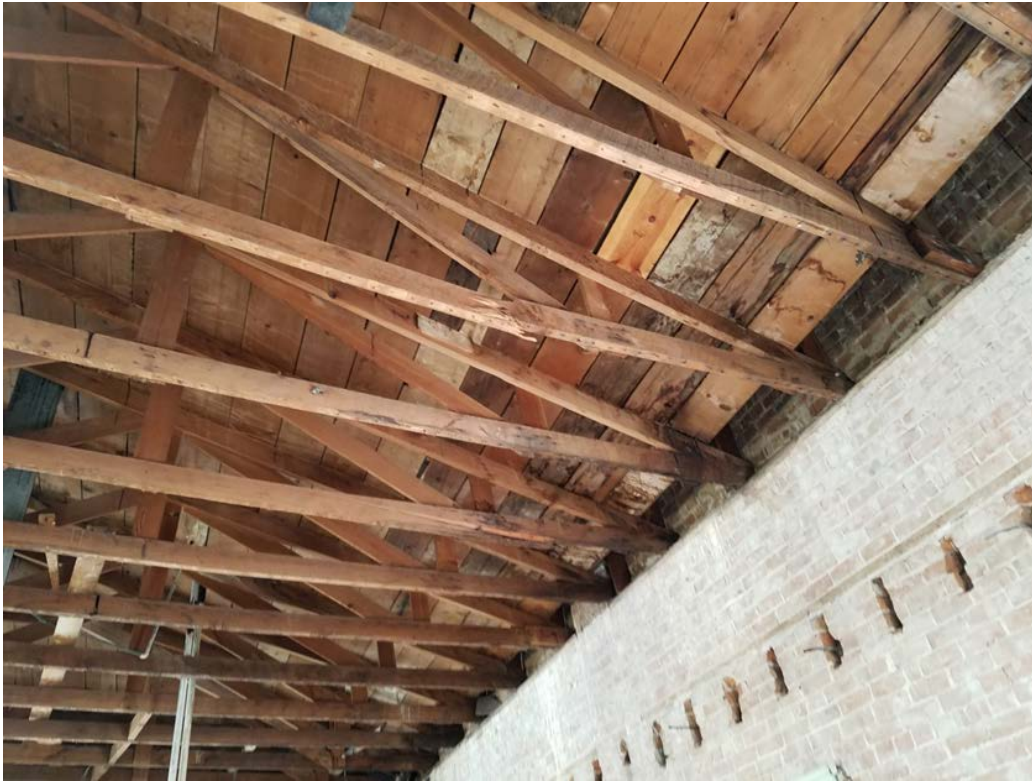
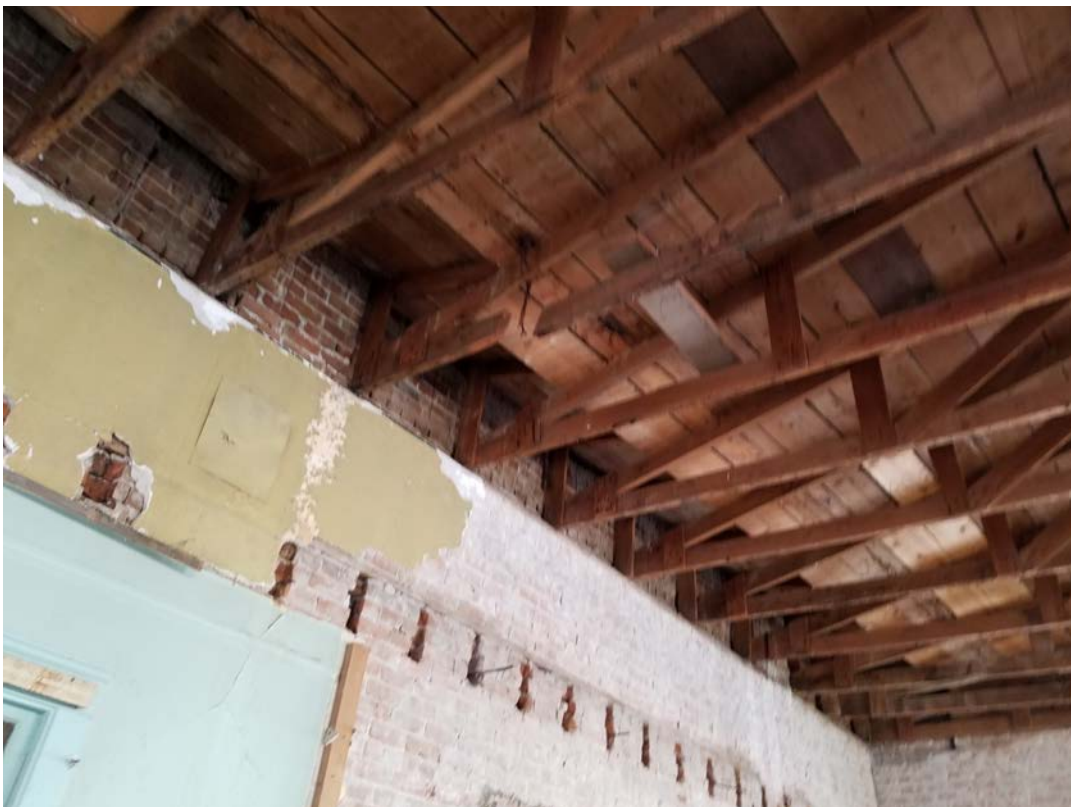
1. The roof framing consists of what we believe is 1x wood planking spanning to site built wood trusses at 24" to 28" on center, that clear span the entire building and bear on the 4" ledge formed by the step from 12" to 9" in the brick walls. The roof trusses are in severely bad condition with water damage, numerous broken bottom chord members, and visibly excessive deflection.
2. The original ceiling joists appear to have been connected to some steel wall anchors (as observed). These anchors are obviously no longer attached to anything and this may leave the upper walls without a connection to the roof diaphragm.

Figure 4 & 5 - Broken Roof Trusses & Original Ceiling Joist Pockets

4. The roof is in such distress it must be considered dangerous and must be replaced. We are recommending on our concept plan to install new light gauge steel trusses that form a mansard type roof that creates a mechanical well that can be used to support the required mechanical units. See attached detail CS2. The trusses as we are proposing will also attempt to match the original roof lines of the building that may be a consideration with respect to the historical aspects of the building.

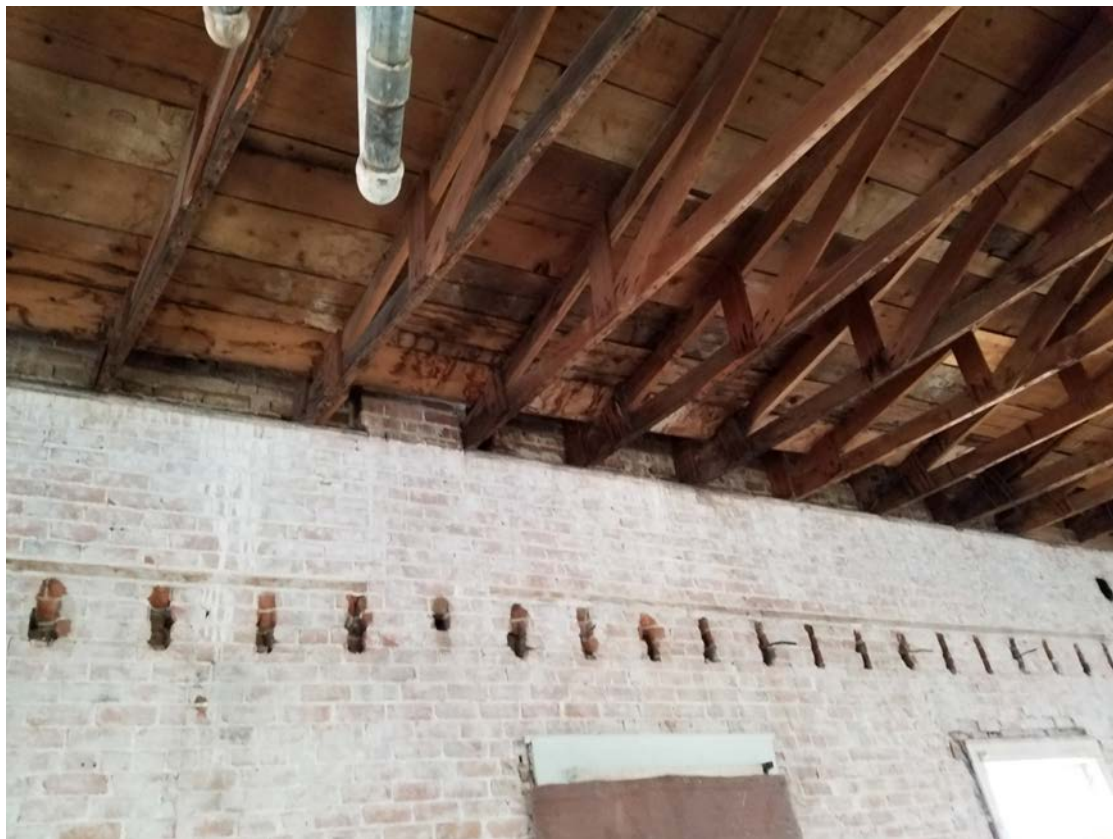
Figure 6 – More Broken Trusses & Original Ceiling Joist Pockets

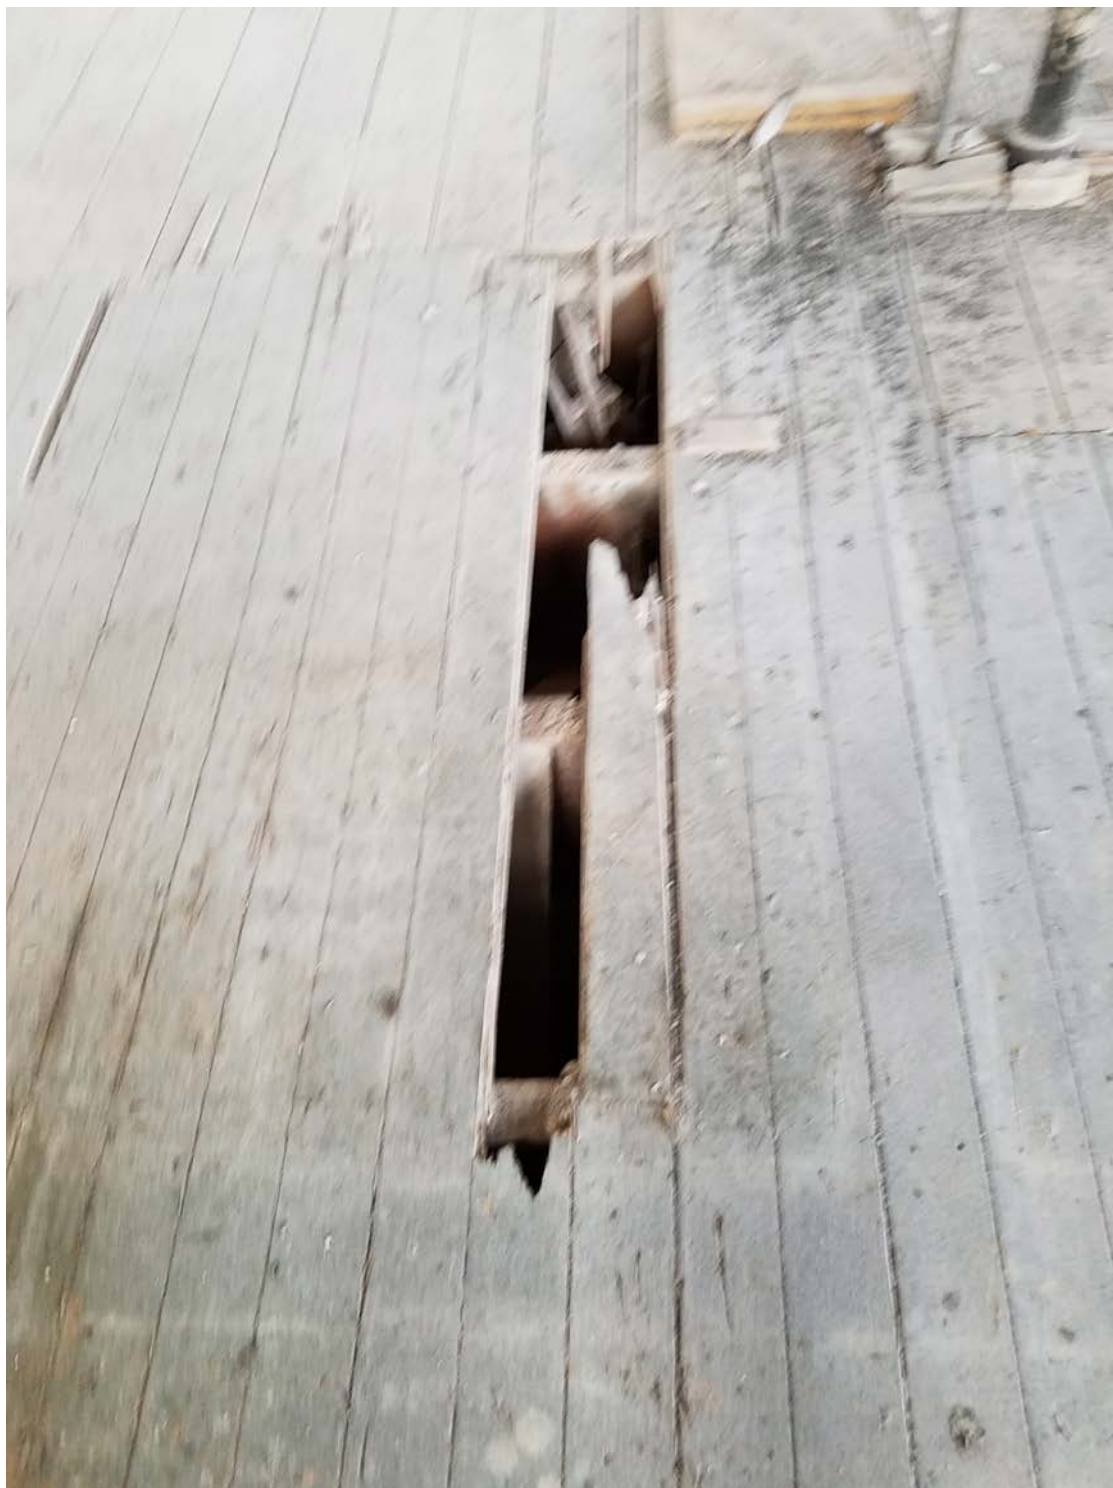
Figure 7 – Floor Decking

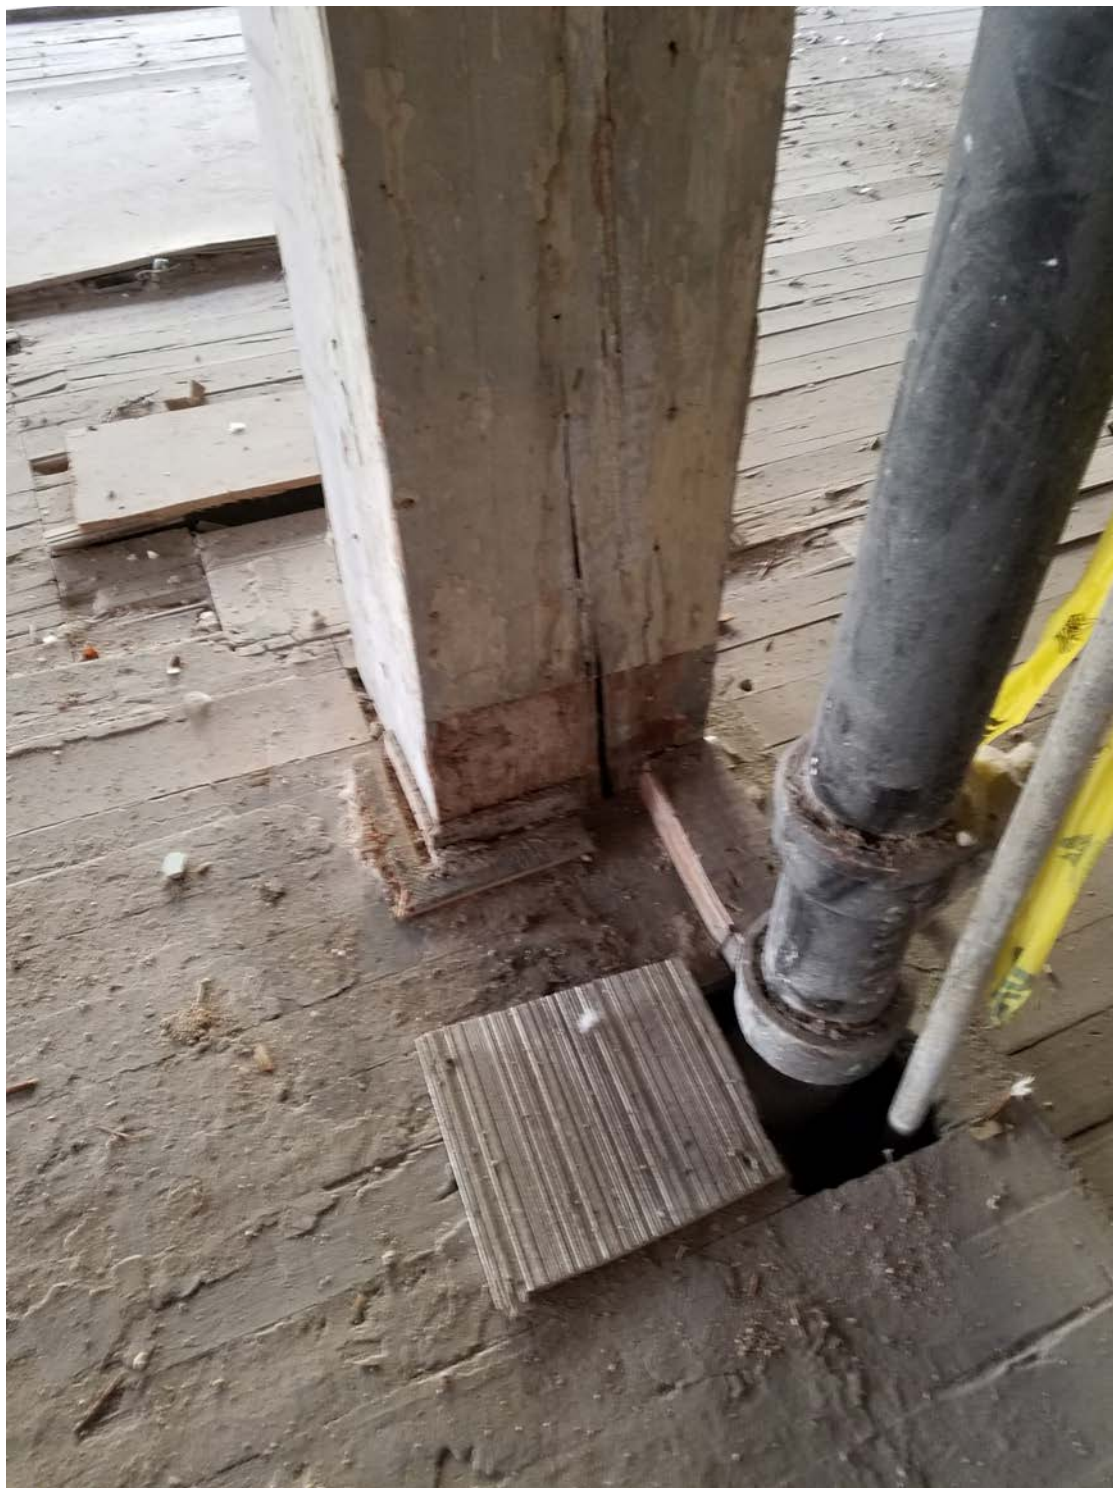
Figure 8 – Wood Post At Floor Framing

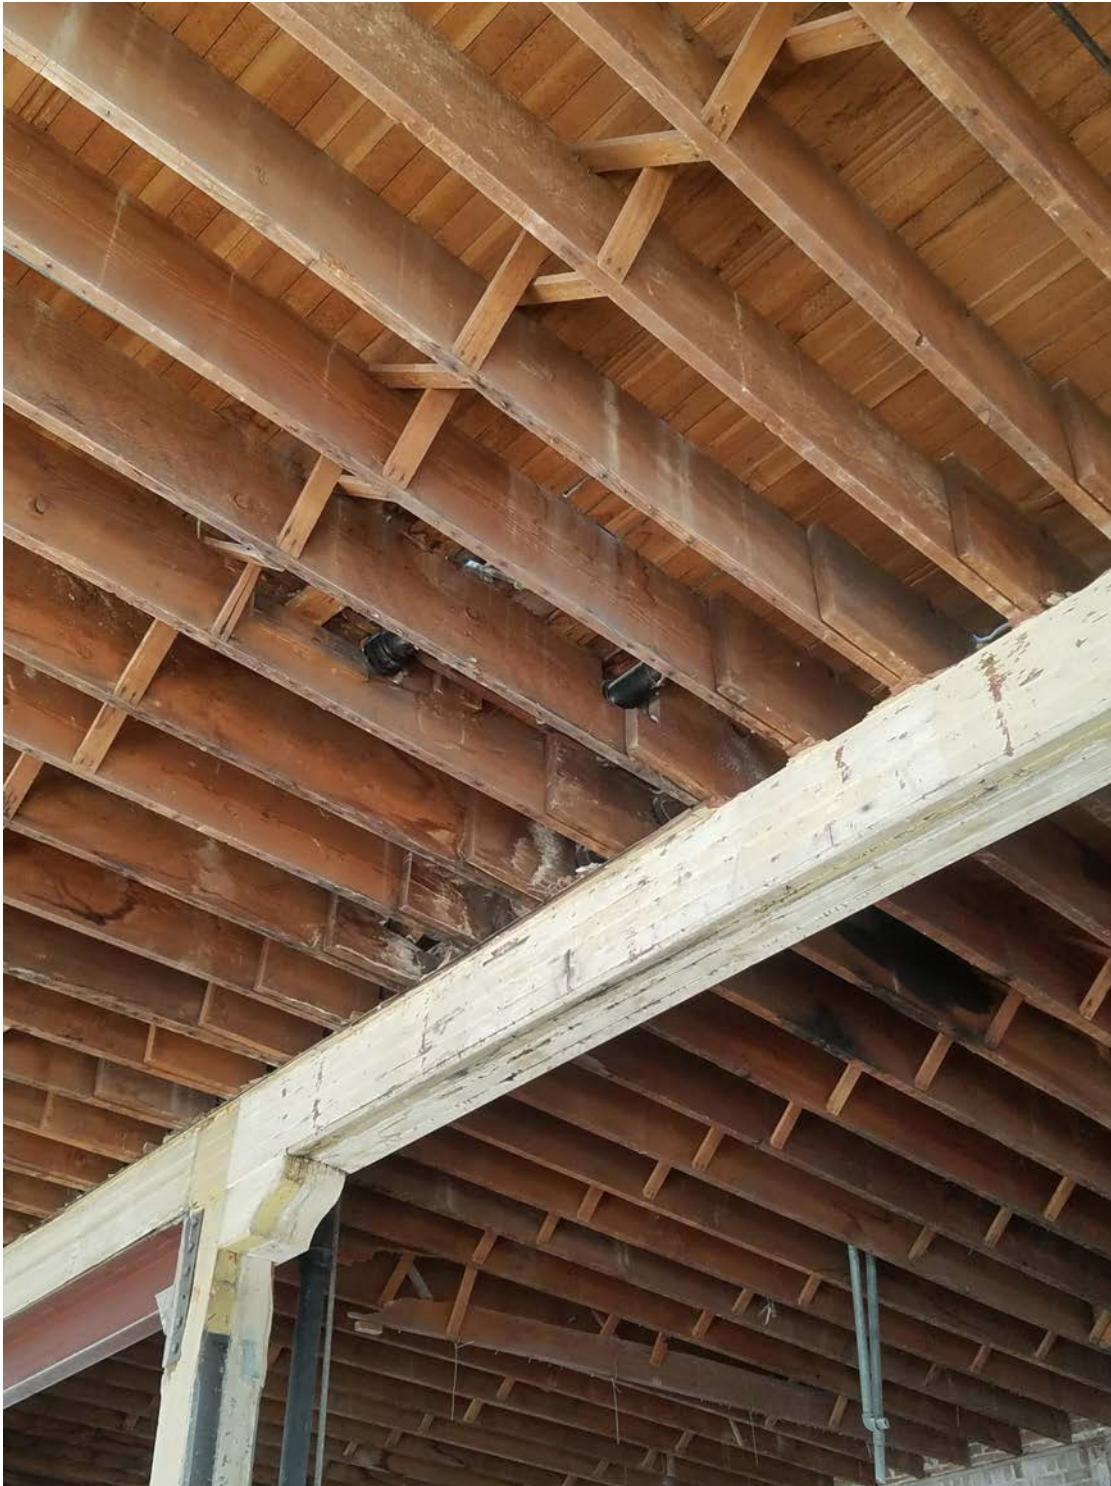
Figure 9 – Second Floor Girder and Broken Joist

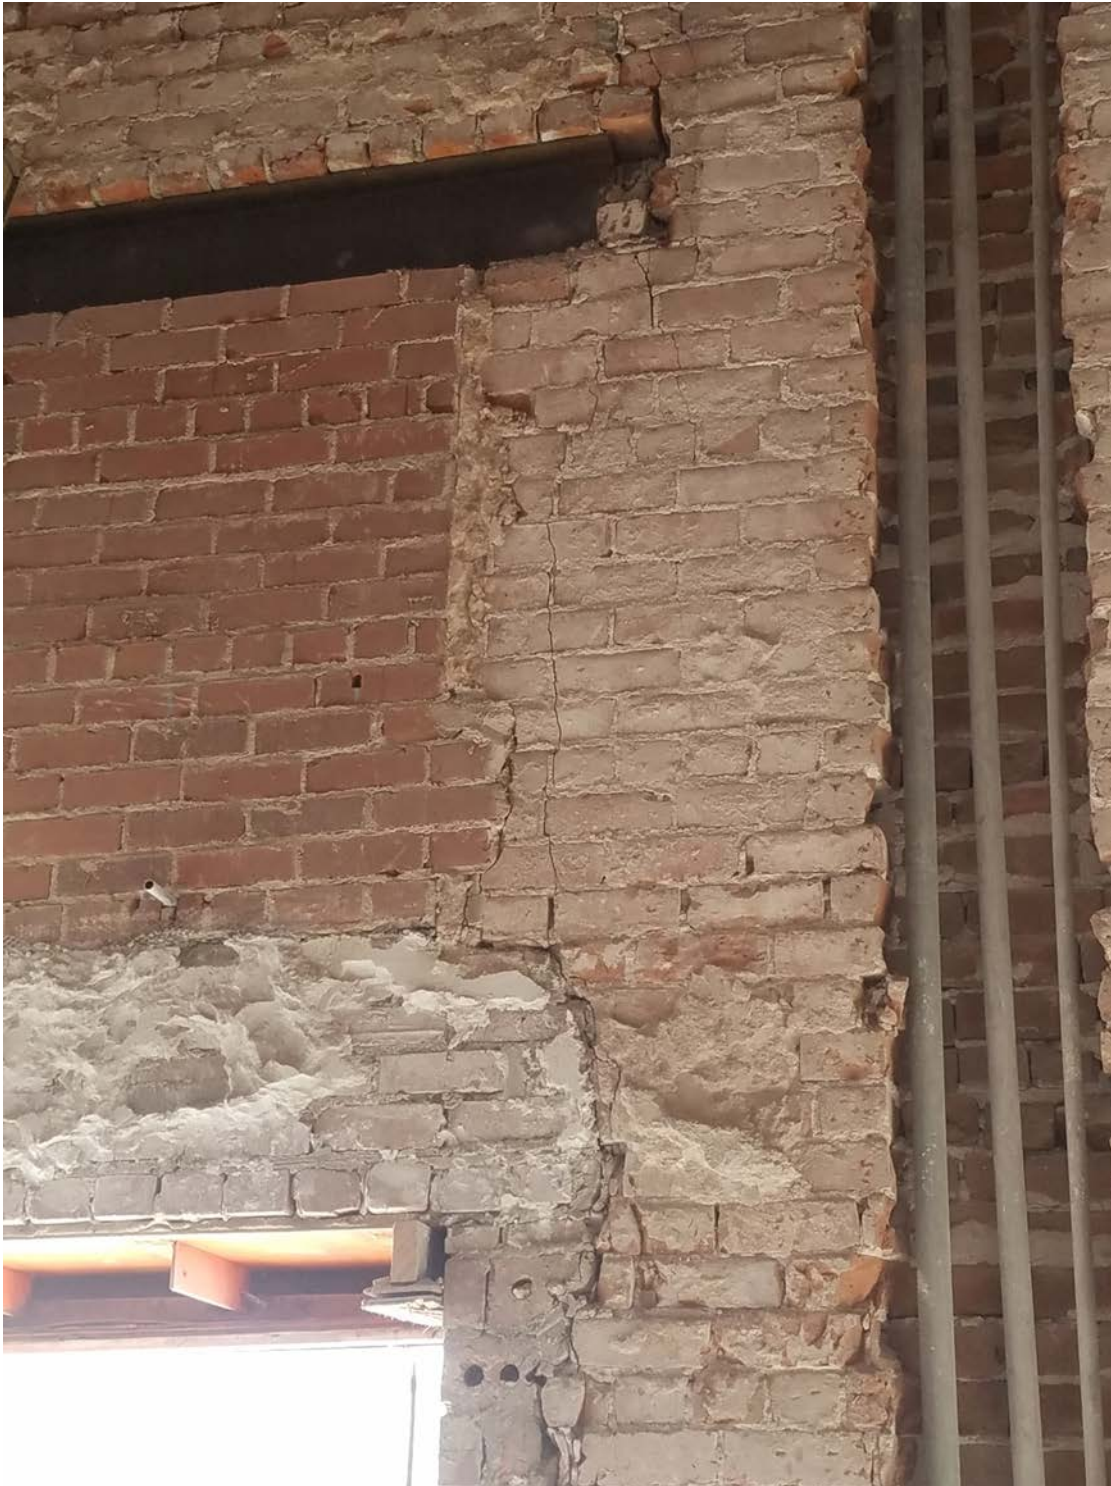
4. There are very wide window and door openings on both the east and north walls of the ground floor, with only short piers in between the opening. We observed several cracks in these areas that are a major concern.

3. There are numerous window openings on all the walls with narrow (+/- 16" wide) piers in between the openings. We observed several cracks along with numerous areas where mortar is missing.

Figure 10 – Vertical Crack at Window Pier

5. All of the mortar for the brick walls must be pointed on both the interior and exterior faces. The existing cracks that were observed will need to be repaired.

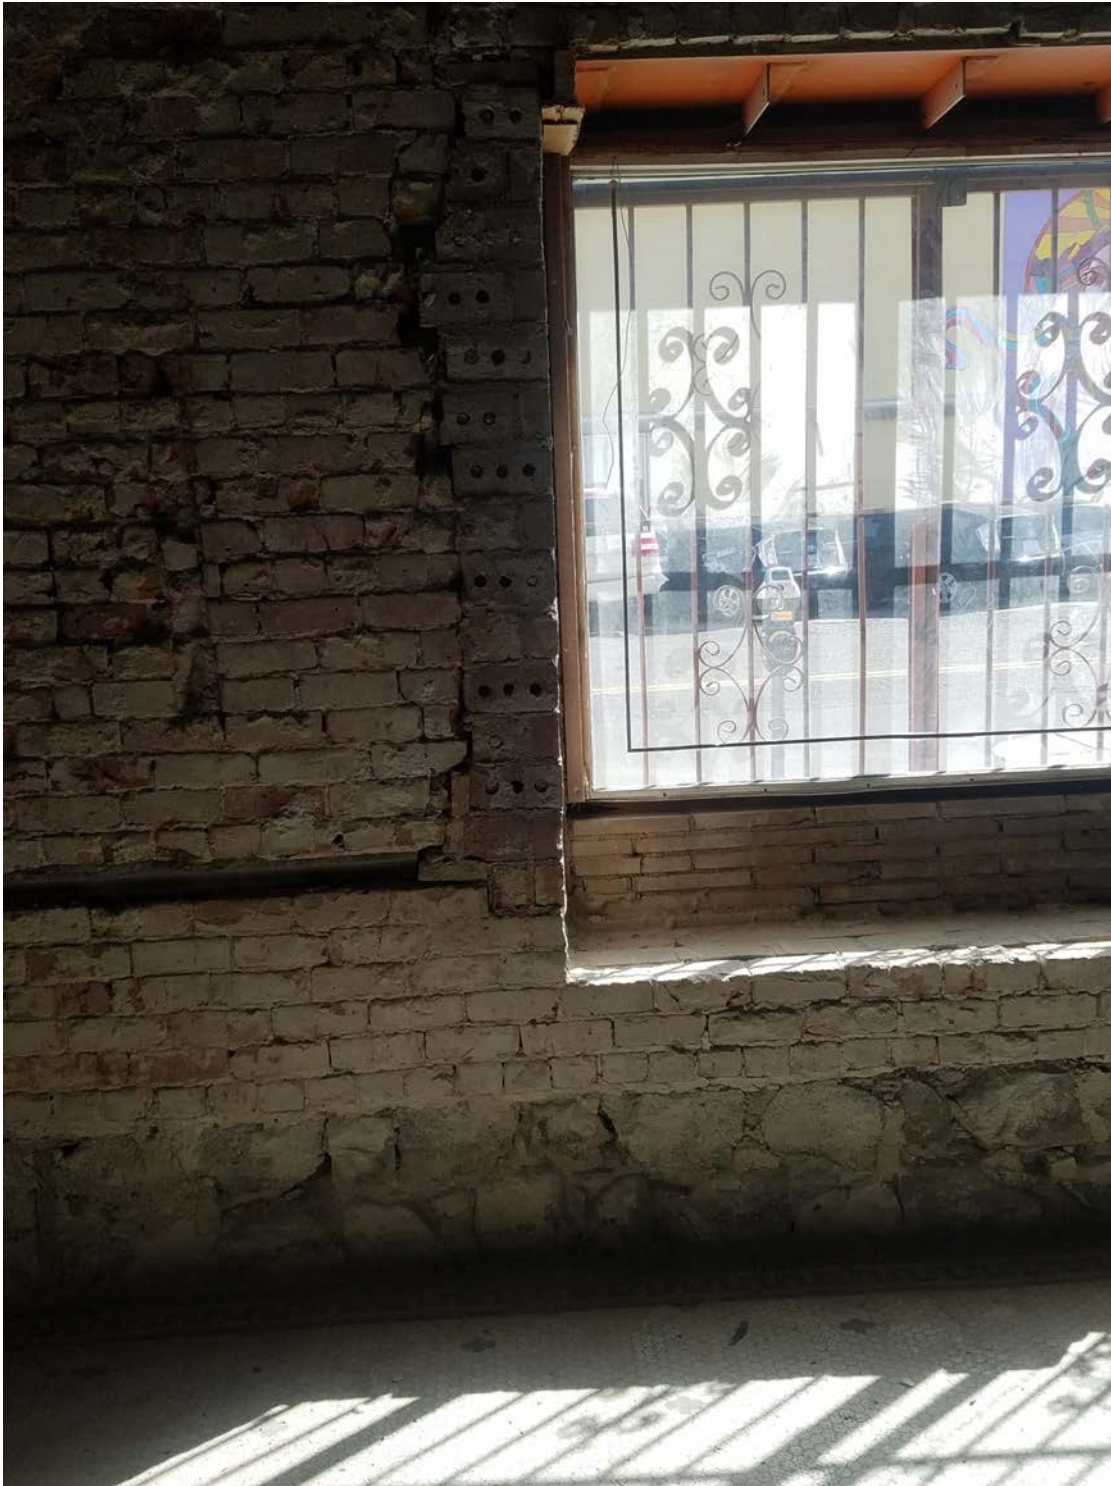
Figure 11 – Brick Wall at Window Opening
