HISTORIC BUILDING ASSESSMENT REPORT THE REBEIL BLOCK/INDIAN VILLAGE

09.01.05
CONGRESS @ SCOTT TUCSON, AZ

Prepared by: **Vint & Associates Architects Inc.**
312 East Sixth Street Tucson, Arizona 85705
tel: 882-5232 fax: 882-5449

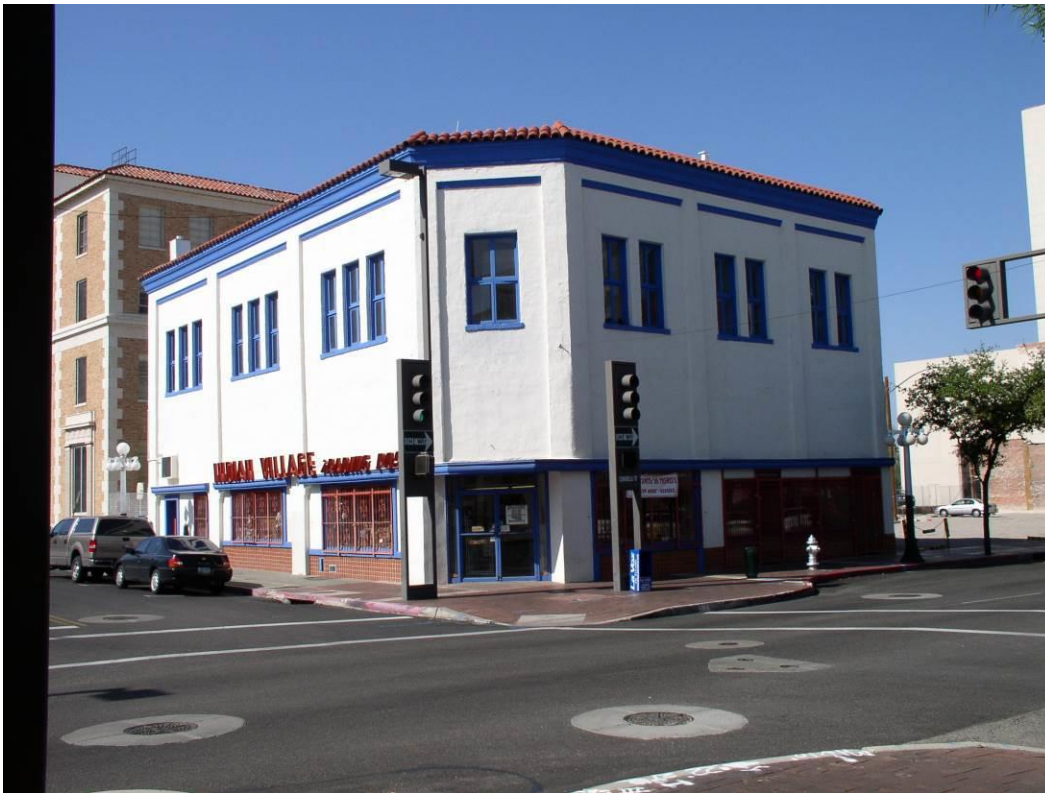
View of north and east facades, August 2005. Photo: A. Calahorro. The structure appears stable despite the fact that it is built of unreinforced brick and is over 100 years old.

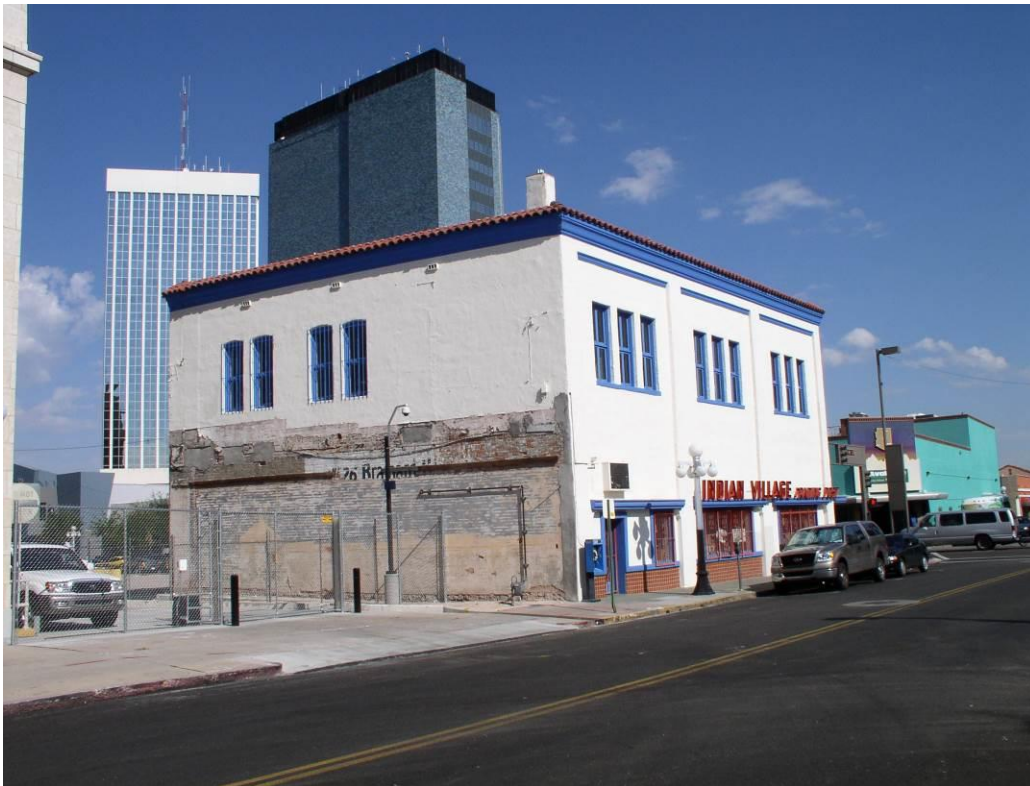
View of south and east facades, August 2005. Photo: A. Calahorro. The windows on the south wall retain their arched tops. These windows would not be permitted under today's building code, because they're on the property line. They should be preserved if possible because of the historic nature of the structure.

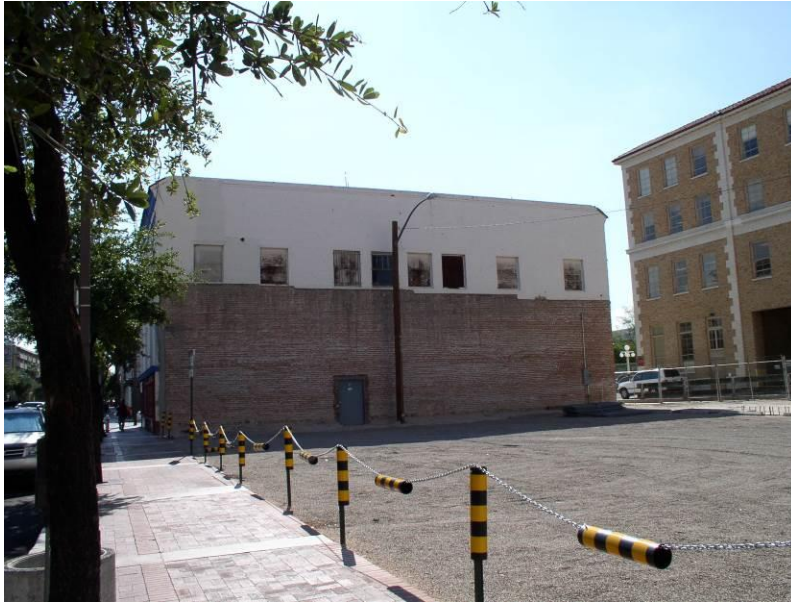
View of west wall, August 2005. Photo: A. Calahorro The windows on the west wall are boarded up with one exception. Vacant lot is site of "The Post"

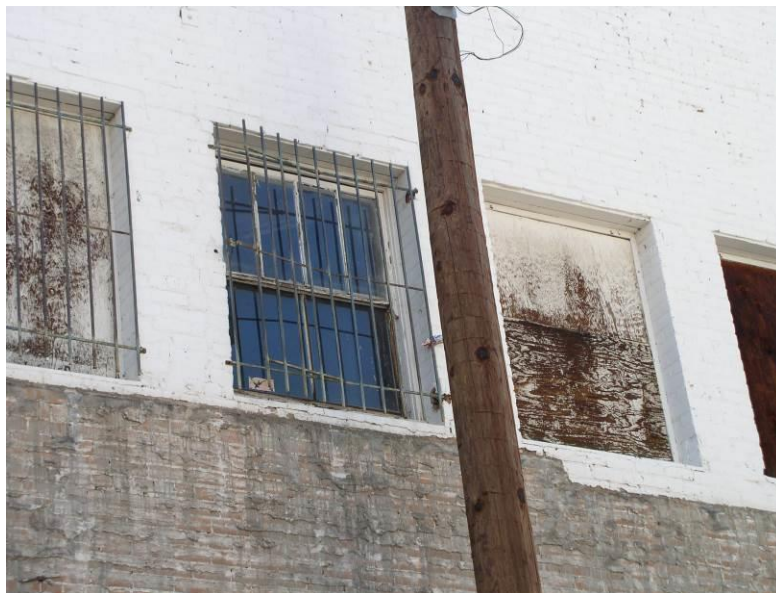
Detail of west wall, August 2005. Photo: A. Calahorro. Windows on the west wall are 4-over-2 double-hung. Original windows are in place, although boarded up except at upper landing of stair.

- F. Replace non-original casement windows with wood sash one-over-one light double hung windows per historic period photos. Consider re-painting the "Petrocelli" sign.

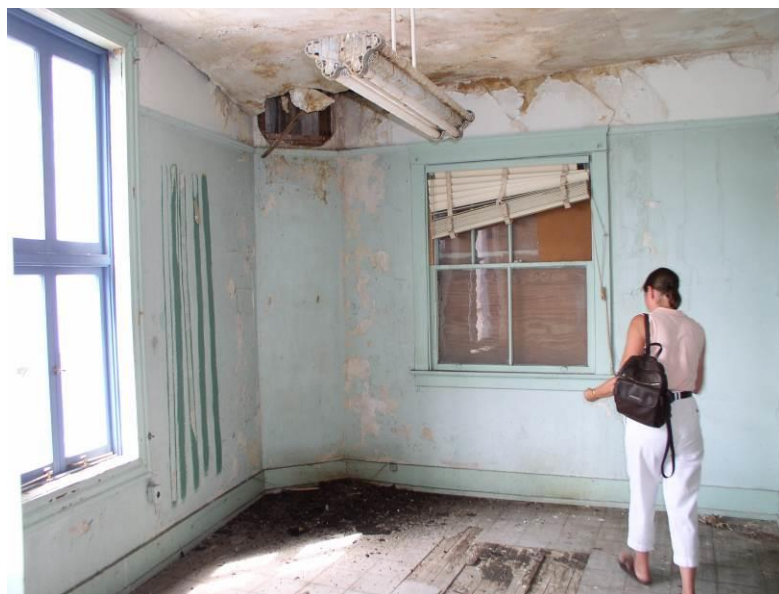
Interior of room at southwest room second story. Note boarded-up window, damaged plaster ceiling, condition of floor. Photo: B. Vint

The low-quality wood casements installed in the 1980s are not secure against weather or birds, and as a result the interior is a mess. Crumbling plaster-on-wood-lath ceilings are evidence that the roof has leaked chronically for an extended period of time, although reportedly this has been remedied in recent months. The lath-and-plaster ceiling installed at ten feet above the second floor level is not original to the 1897 building. The author was able to view the attic space above the plaster ceiling (which has in places a perforated Masonite acoustic tile) and found that there is a finished bead-board ceiling continuous above. The second floor partitions do not appear to be structural, as they stop at the lower ceiling. This suggests that the roof is free-spanned by deep trusses, from east to west. This is consistent with the roof form.

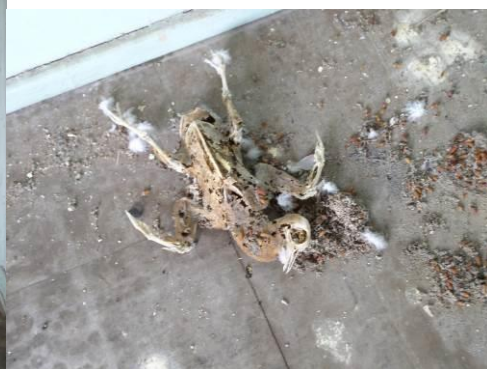
Anatomy of a bio-hazard: dead pigeons amid droppings on asbestos floor tiles.

The second floor is in even worse condition. The floor area is subdivided into a rabbits warren of small offices, hall ways and toilet rooms. It has been abandoned for several years, judging from the dates of old newspapers lying around amidst the accumulated pigeon droppings. The upper floor is at this point a bio-hazard site, requiring remediation as soon as possible.

Beyond heavy pigeon infestation it is likely that asbestos is present in the building (material testing is outside the scope of this Report). The nine-inch-square floor tiles are likely VAT (vinyl asbestos tiles), and there may be asbestos fibers in the black adhesive used to adhere the tiles to the original wood floor beneath. ***A high priority, and first step to be taken in the rehabilitation of this historic building, is a hazardous materials assessment and remediation.***

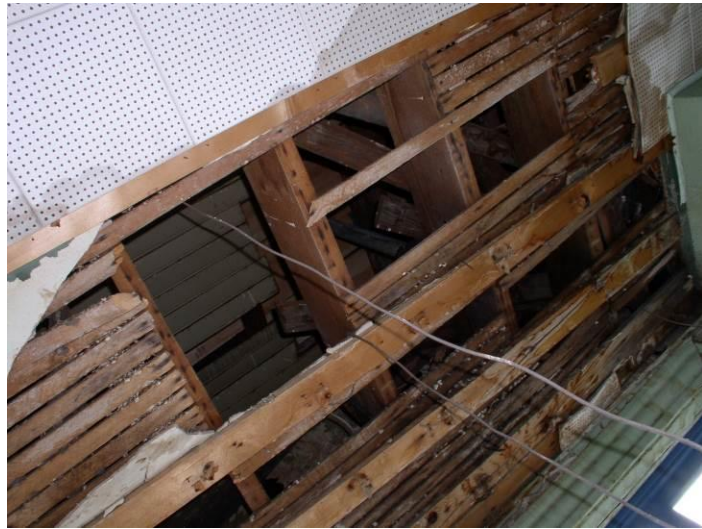
View of lath & plaster ceiling on wood joist framing. Photo: B. Vint

The ceiling boards and joists look to be in generally good condition. The leaking roof seems to have affected the non-original plaster ceilings worse than the wood structure where visible. This must be verified by a structural review, which is outside the scope of this historical assessment.

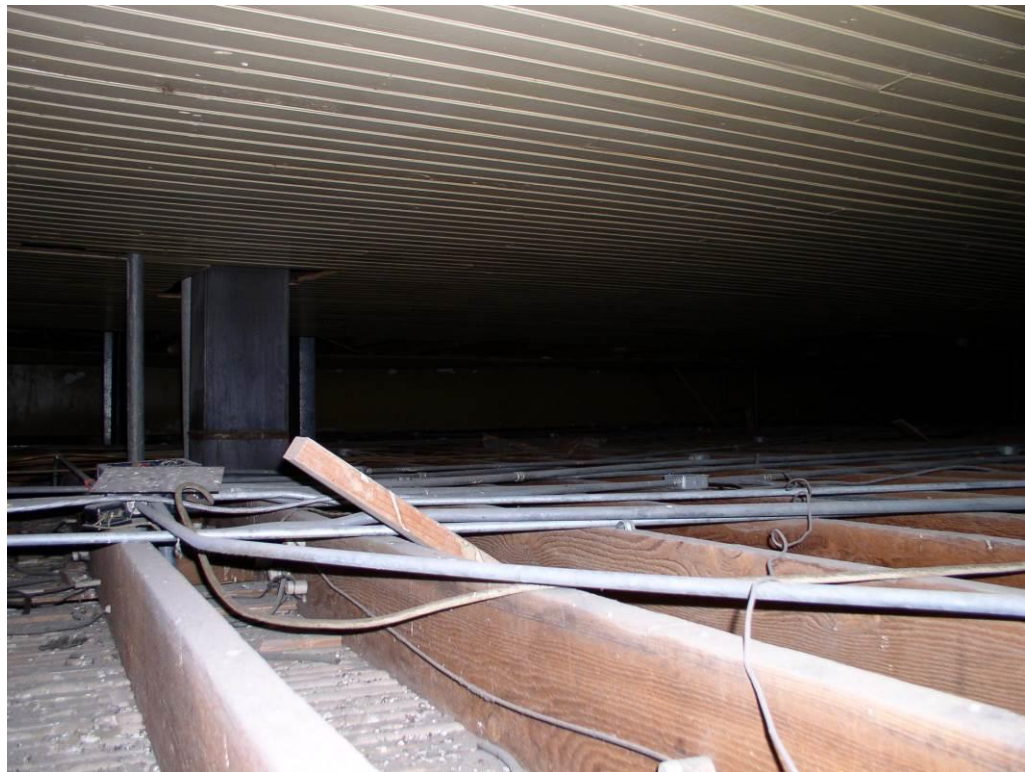
View of attic space, looking west. Bead-board ceiling above spans north-to-south, indicating that the roof trusses to which the ceiling boards are nailed run east-to-west. This is logical, given that east-west is the narrow span for the building. Photo: B. Vint

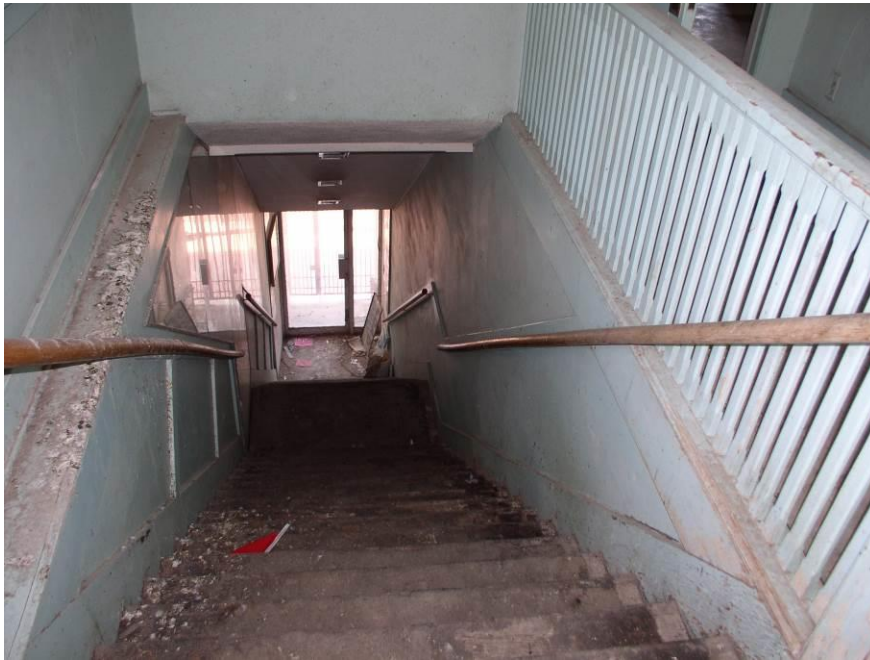
An important original building element is the stairway at the northwest corner, leading from the street to the second floor in a single straight run of 31 risers at 7 inches in height, with one intermediate landing. The floor-to-floor height is 18 feet. The stair needs a new handrail and flooring, but is otherwise in good condition. It is a significant character-defining element worthy of preservation.

View of stair leading up to the second floor in a straight run. Photo: B. Vint

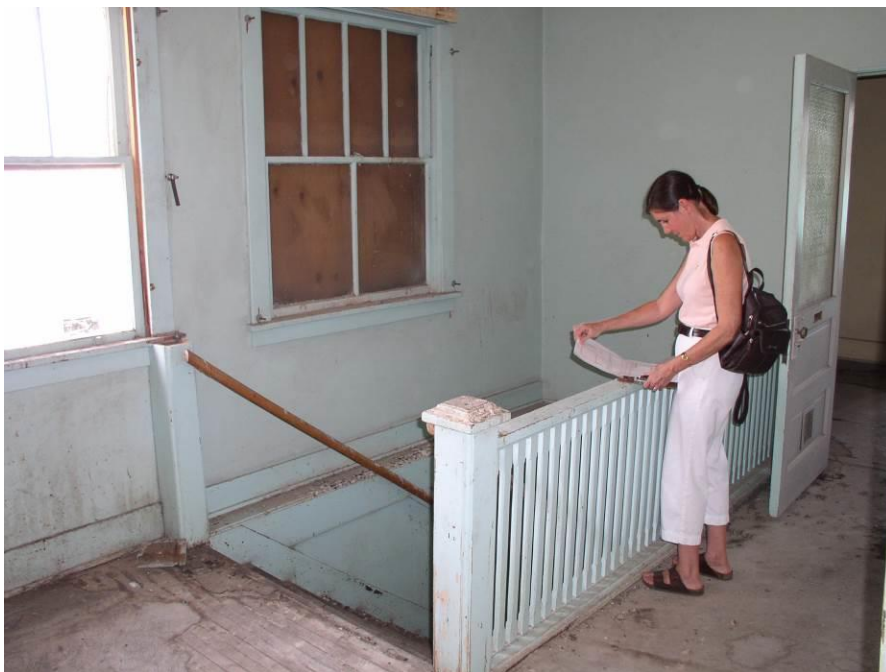
Railing and banister are intact. Note original window boarded up. Photo: B. Vint
