HISTORIC BUILDING ASSESSMENT REPORT THE REBEIL BLOCK/INDIAN VILLAGE

09.01.05
CONGRESS @ SCOTT TUCSON, AZ

Prepared by: **Vint & Associates Architects Inc.**
312 East Sixth Street Tucson, Arizona 85705
tel: 882-5232 fax: 882-5449

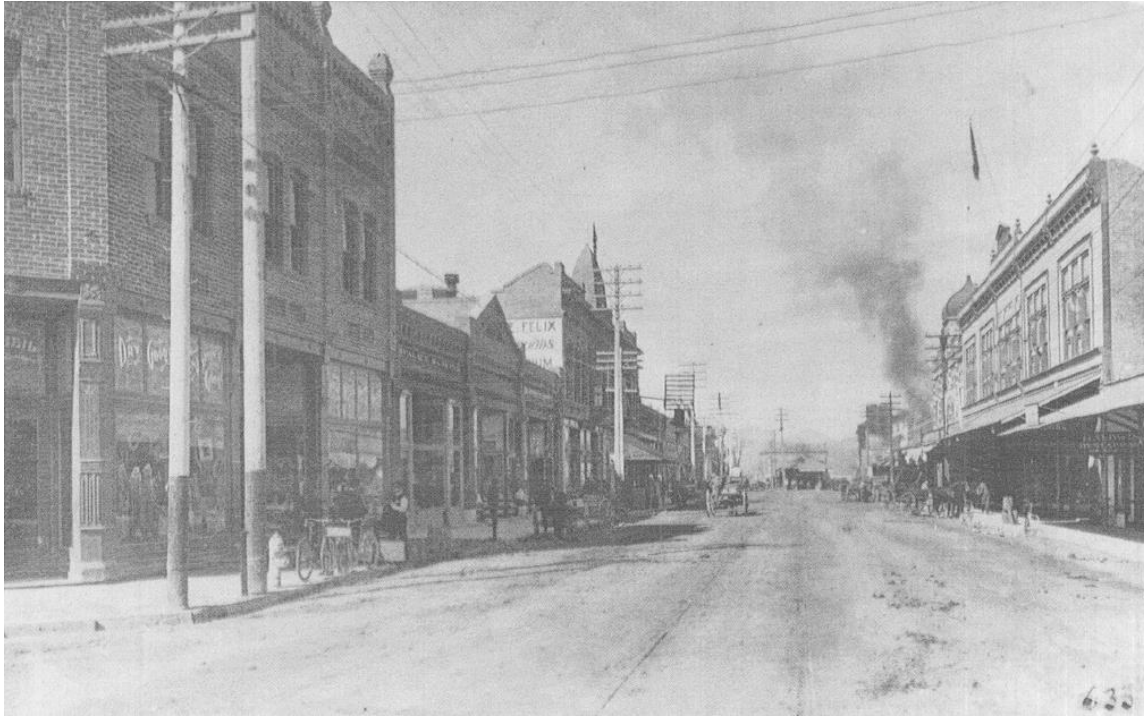
*Rebeil Block, ca. 1905. Cast iron storefront visible at corner and north elevation, with deep recessed entry at the center of the three structural bays. Cast iron columns and beams may still exist beneath stucco.
Courtesy of Arizona Historical Society, A.S. Reynolds Collection #633*

- A. Remove stucco above existing windows on north wall and at northeast corner to see if original cast iron store front is still there. If cast iron is intact, it should be restored; if it's missing, it should be recalled through the construction of a contemporary interpretation of the same principle. The insertion of steel frames to re-open the north window may also be used to strengthen the building against lateral forces.

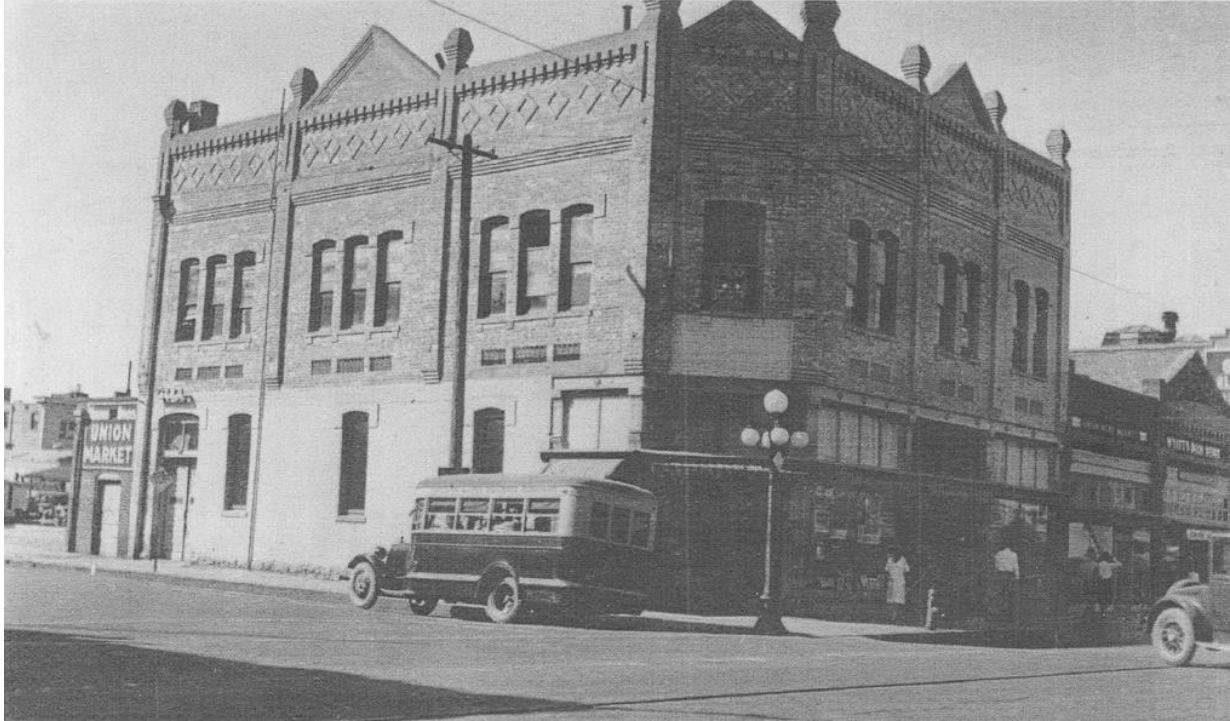
Rebeil Block, ca.1925 photo courtesy of Arizona Historical Society AHS # 6618 The best view of the original design. Note "High Victorian" brickwork and parapet, and cast iron facade at north and northeast corner. Chamfered corner for entry is typical of the period. Historic windows were one-over-one light double-hung wood sash.

- F. Replace non-original casement windows with wood sash one-over-one light double hung windows per historic period photos. Consider re-painting the "Petrocelli" sign.

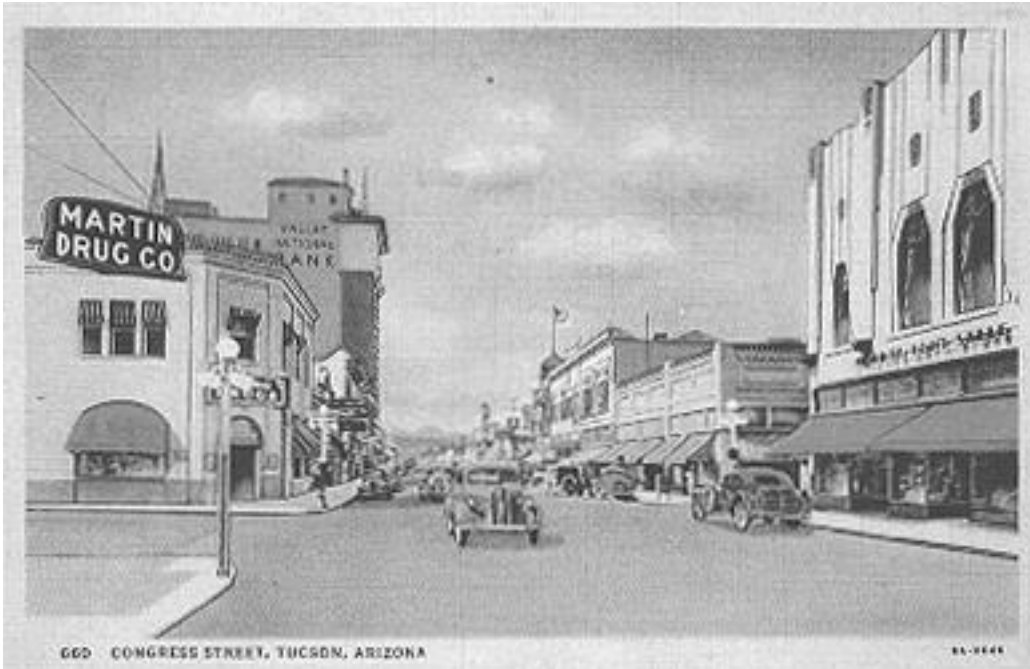
Rebeil Block ca. 1934 postcard view. The building has been stuccoed and re-styled in the Spanish Colonial Revival mode popular in the 1930s, as the city tried to re-make itself in the image of the "Old Pueblo." The brick parapet has been removed. Fabric awnings of a different form are still in use at both levels. The sign in the foreground reading "Martin Drug Co." is in fact across the street on the east side of Scott Ave.

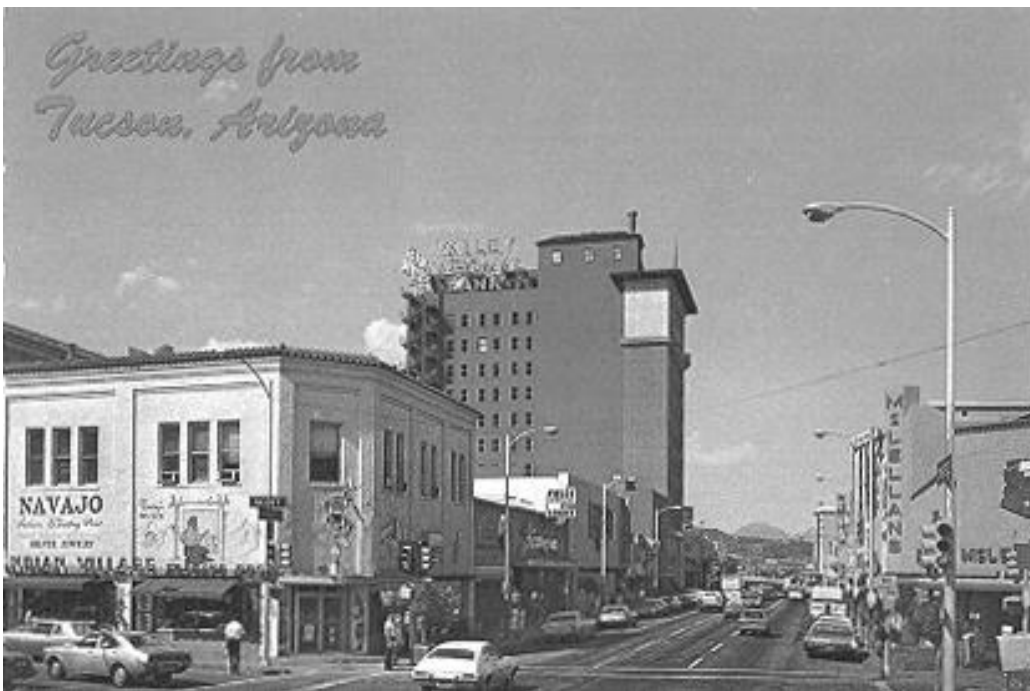
Rebeil Block, ca. 1968 postcard view. That the Rebeil Block/Indian Village has been pictured on numerous post cards through the decades indicates its status as a community landmark, likely due to its prominent corner location. Note awnings at east windows of 1st floor and murals of Native American figures. The chamfered corner featured a neon Hopi Hoop Dancer, whose multi-colored hoops would light up in succession. The sign itself was a local landmark, and reportedly still exists. It was taken down because it didn't meet the City's more recent sign code.

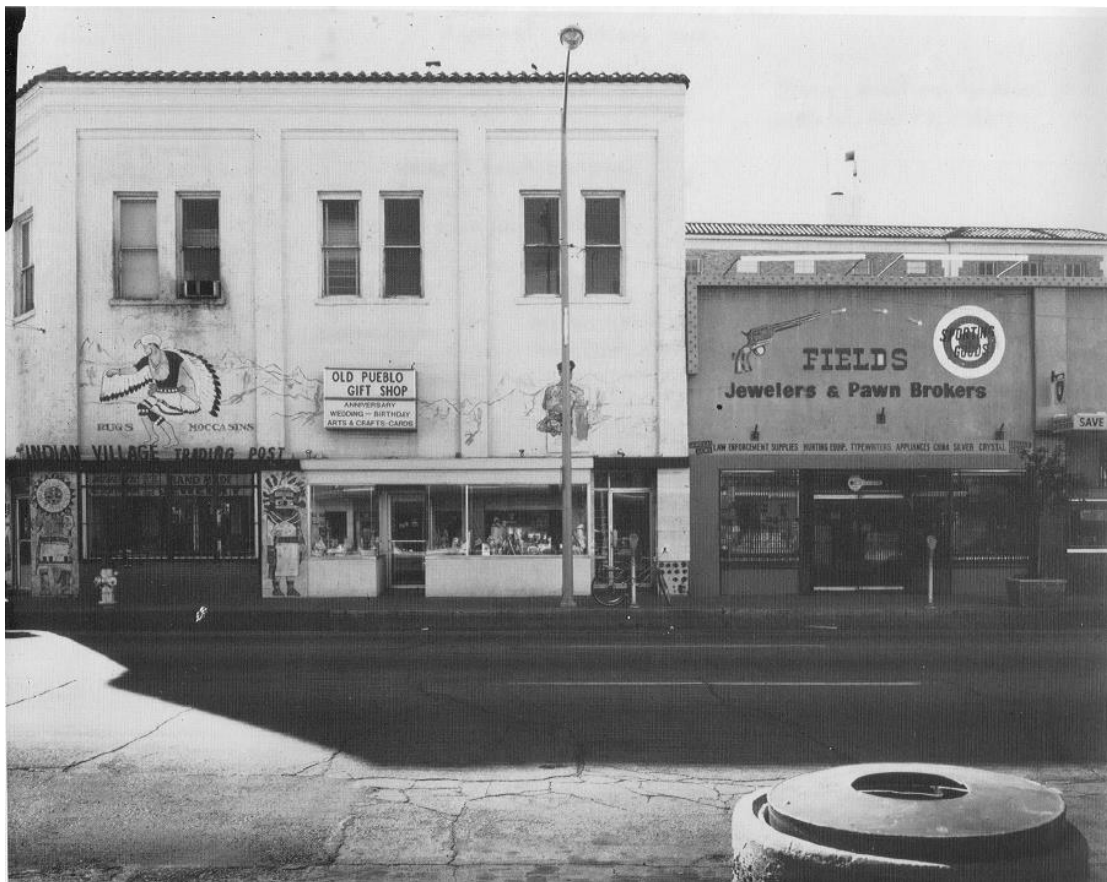
Photo 1980, by James Brett, courtesy of James Gresham, FAIA; Note 1950s era re-modeling of store front and murals of Native American dancers, kachinas and weavers. In the 1950s, Native American artists would weave rugs in the windows, while dancers performed on a platform on the sidewalk.

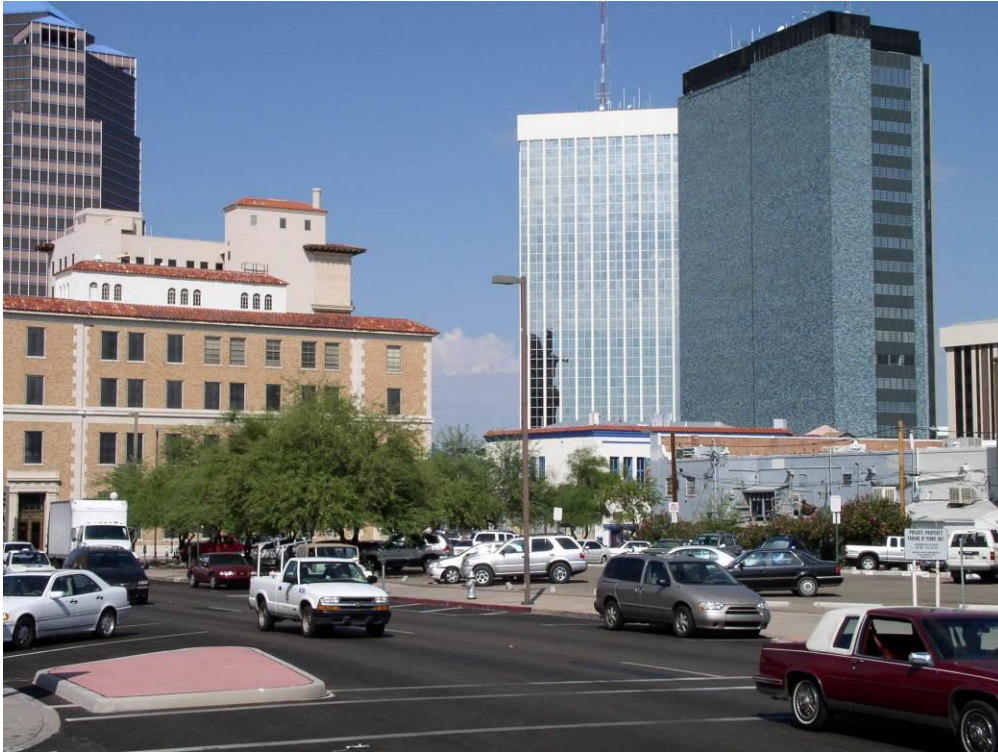
View looking northwest from Broadway @ 6th Avenue. Photo: B. Vint From this vantage point it is clear that the site will accommodate a large building in context. The Rebeil Block /Indian Village is visible at the center of the photo, with the red tile band at the parapet.

3. **STEP MASS OF NEW BUILDING @ HISTORIC BUILDINGS:** This is consistent with the structural recommendation to keep the higher portion of the new building away from the old (ref Item C.2, following). Fortunately, as seen in the photo below, the urban context of this building is such that it will support a taller building adjacent. It is within one block of the tallest structures in Tucson, and the overall massing of the building in the city will be in context.
